**NEVADA PROPERTY CONCEPTS**

# Inspection Report

**Property Address:**  
2870 Augusta Dr.  
Las Vegas NV 89109

<b>Date:</b> 5/15/2017	<b>Time:</b> 09:00 AM	<b>Report ID:</b> 20170515-09.00SP
<b>Property:</b> 2870 Augusta Dr. Las Vegas NV 89109	<b>Customer:</b> Mr. Phil Edgar	<b>Real Estate Professional:</b> Jamie Tsai O' Harmony Realty LLC.

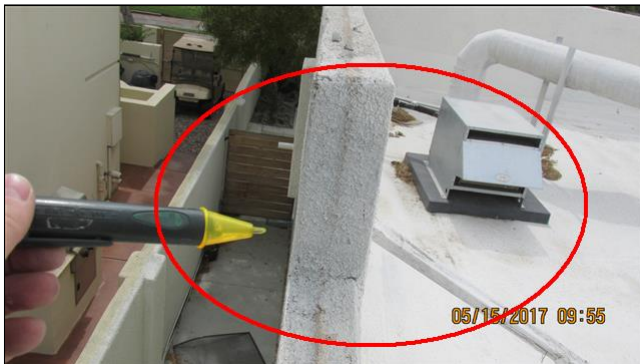
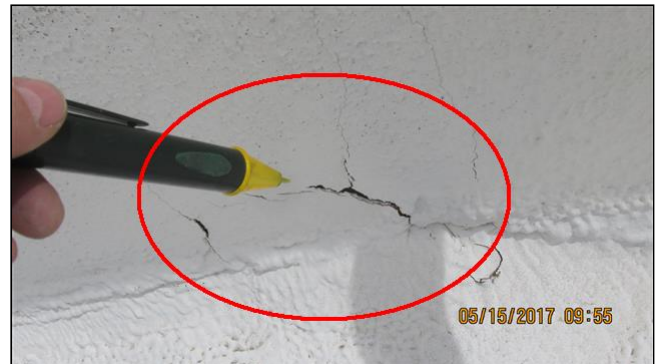
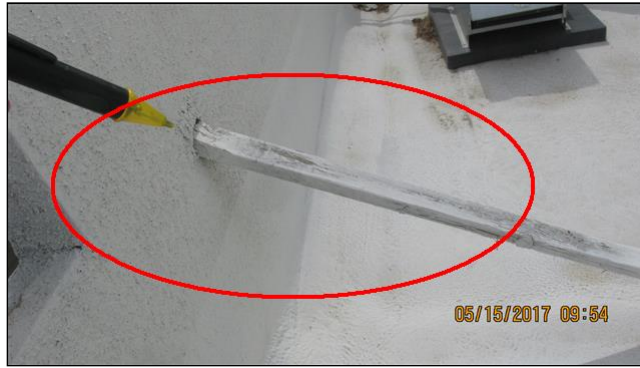
(2) Signs of significant cracking and movement are visible in portions of the rear left corner where wall meet a roof. For further information regarding these conditions, a qualified contractor or structural engineer should be retained for evaluation of the stability of the wall, and for analysis and prediction of future performance.

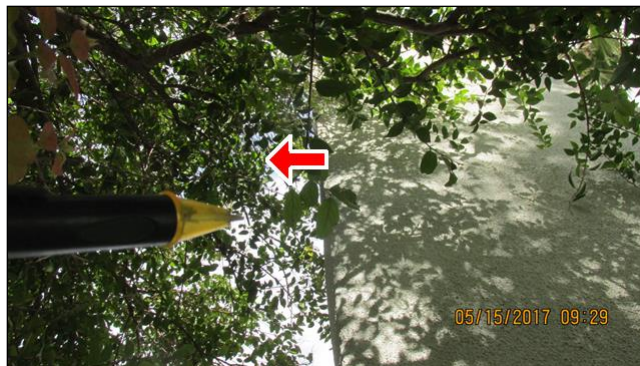
3.2 Item 2(Picture)

(2) At time of inspection, one or more areas of the vegetation were observed to be against or close to the exterior walls. This should also be noted on your WDO (Termite) report. Irrigated vegetation against house walls is conducive to Subterranean Termites.

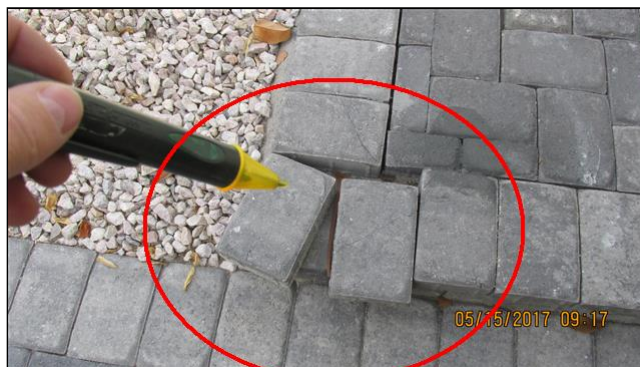
3.3 Item 5(Picture)

(2) One or more areas of the stone masonry at the front of the home are loose / lifted and has created a trip hazard. A qualified mason can make repairs.

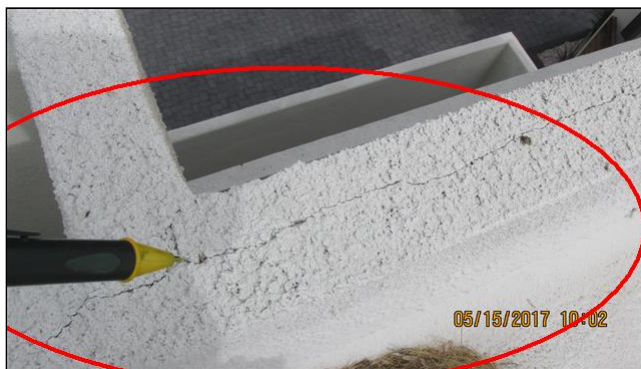
3.8 Item 3(Picture)

- ❌ (2) One or more areas of stucco cladding on a flat surface were observed on this home. Cracks requiring repair were noted. All areas of flat stucco cladding with cracks of any size should be repaired as needed.

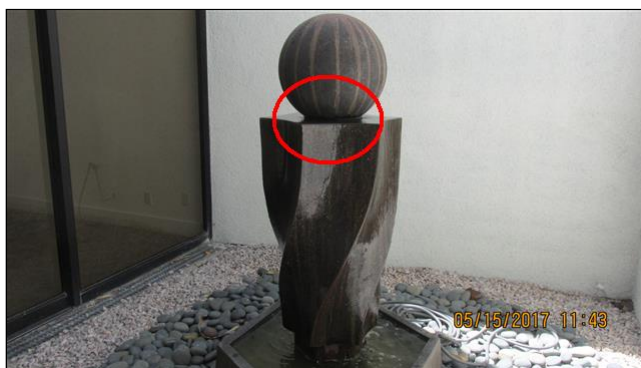
3.11 Item 1(Picture)

- ❌ The fountain components are not secured together. This is a potential child safety concern. Securing the fountain is recommended. A qualified trades person could do the work.

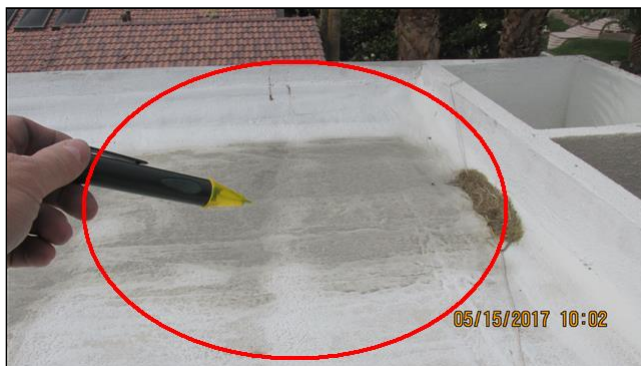
4.2 Item 2(Picture)

- ❌ (2) While some "ponding" is typical for all flat roof covers this roof exhibits excessive areas of ponding and deterioration. This roof should be evaluated by a qualified contractor.

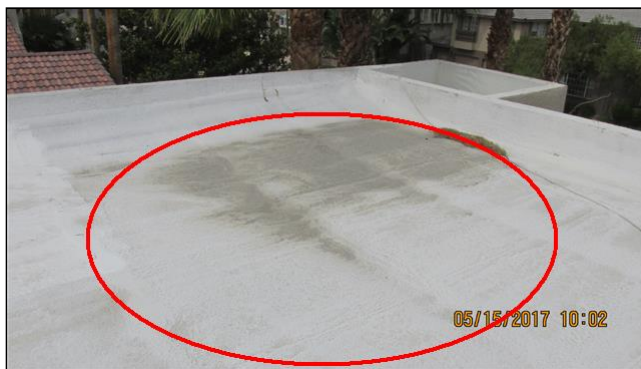
4.2 Item 3(Picture)

- ❌ (3) Blistering noted, this is caused by moisture being caught under the tar layers and expanding in hot weather. Caution should be used when accessing the roof not to step on the blisters to prevent 'popping' them. Recommend

repair by a qualified roofer to be preformed that will involve relieving the pressure under the roofing material and sealing the relief hole to prevent water penetration..

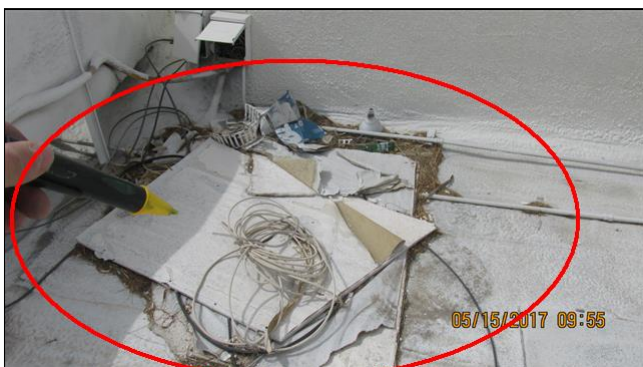
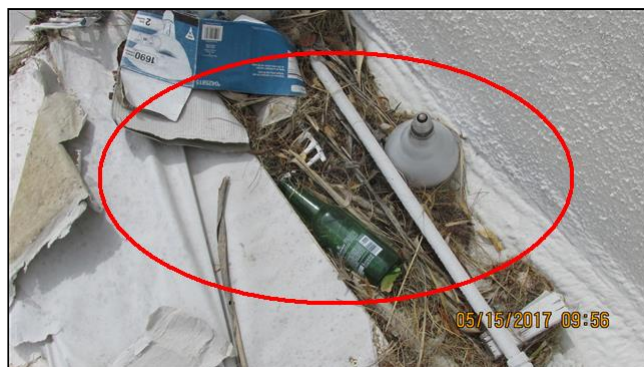
(4) There is non typical material stored on the roof surface. This can damage the roof surface and/or shorten the life of the underlying roofing. Recommend removal of the stored items.

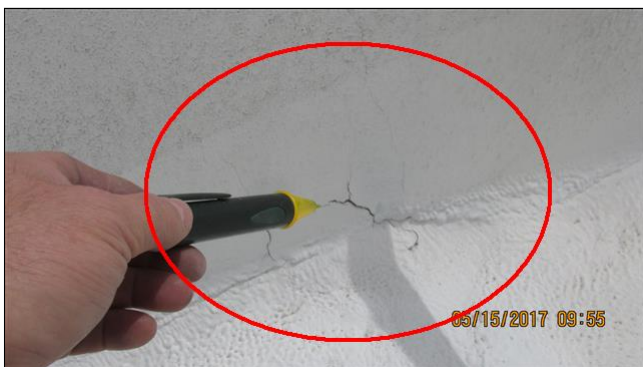
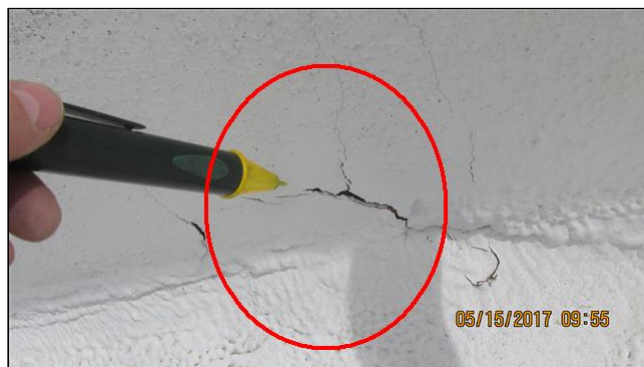
(5) The cap sheet edges at the flat roof cover over the Northeast corner are loose and allowing water penetration to the structure below. Also see EXTERIOR section.

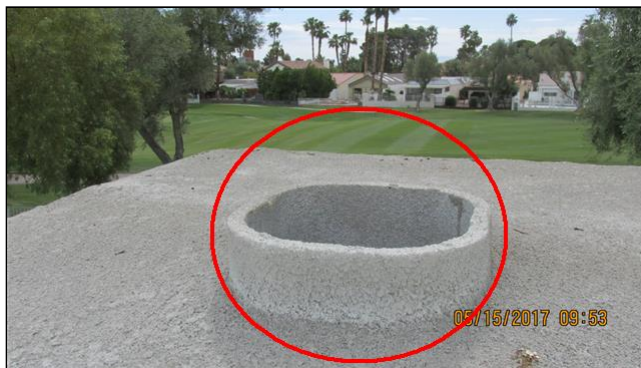
4.4 Item 2(Picture)

(2) No spark arrestor or rain cap is installed at the chimney flue terminal. Caps help prevent the escape of hot embers or rain entry. As an upgrade, a combination chimney cap/spark arrestor should be installed.

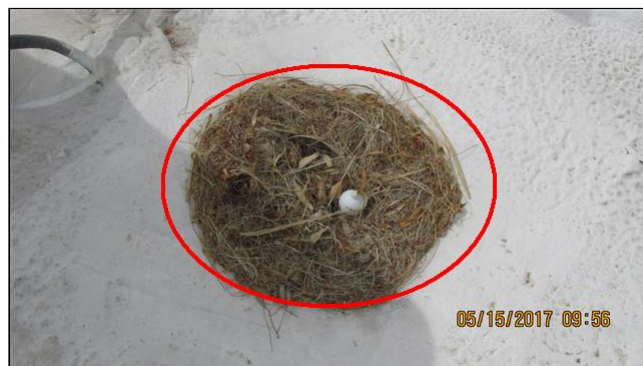
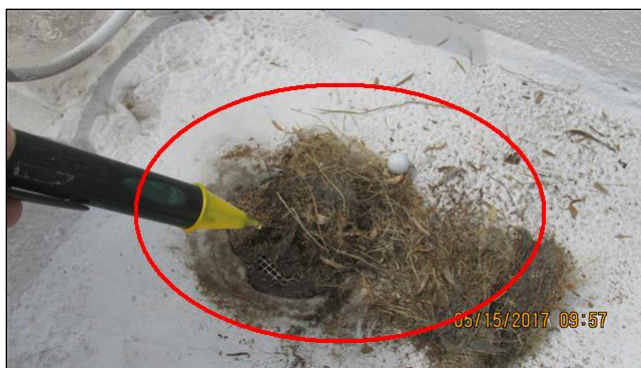
A section of the internal roof drains are clogged with debris, and are not draining as intended.

- SUGGESTION: All debris should be cleared from the roof drains, and the drains should be tested to ensure proper function.

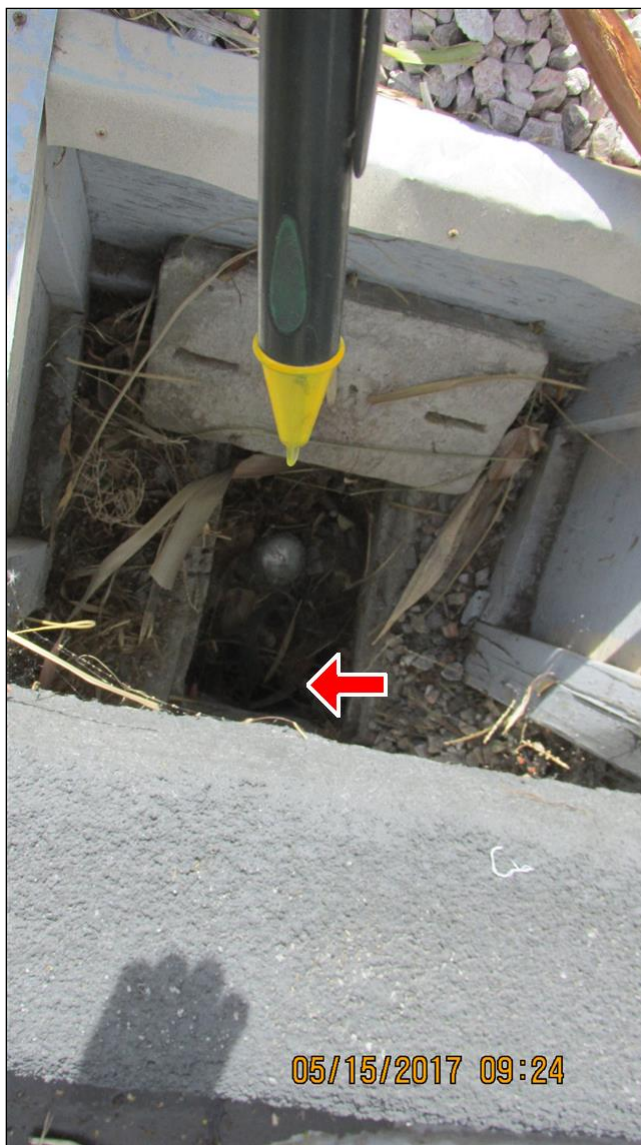
5.2 Item 1(Picture)

When the water is shut off at all the fixtures inside the home the water meter was not turning. This generally indicates that there are no active water leaks. The water meter was turning even though water in the home was shut off. There is a leak/s that need to be repaired.

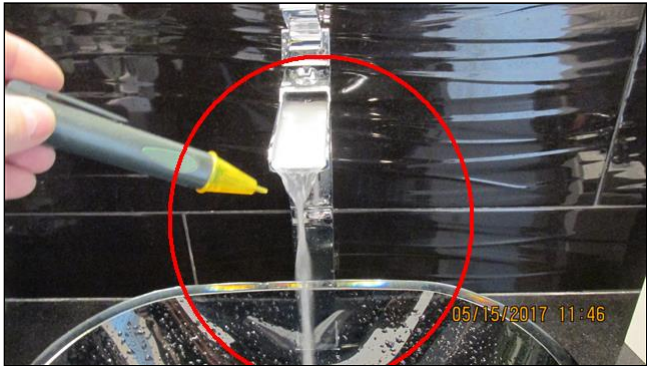
5.3 Item 2(Picture)

(2) The water flow is noticeably low, but the pressure is within the normal range. In our judgment, there is likely a restriction in the supply. A qualified plumber could make repairs or modifications as necessary.

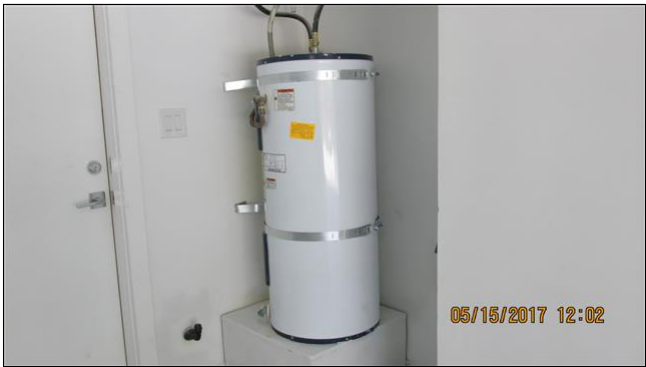
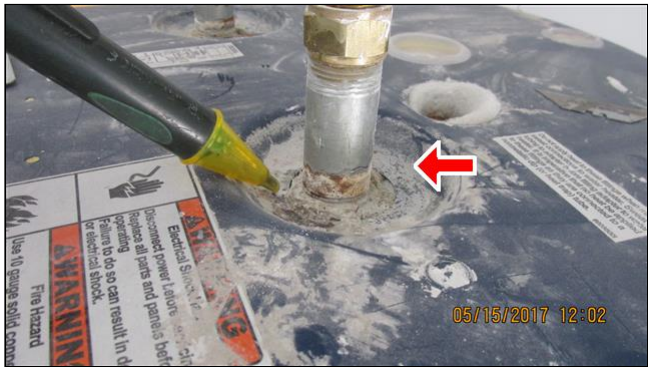
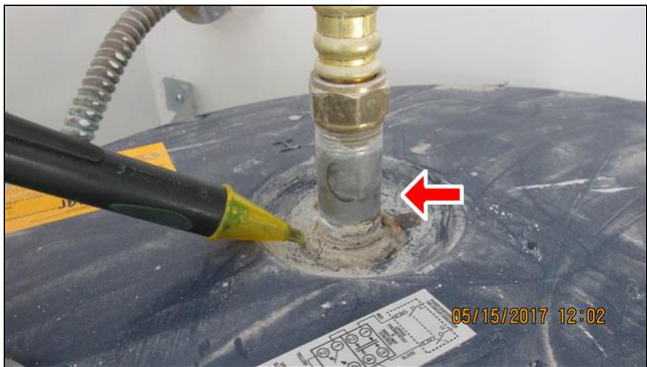
- (2) The water connections are heavily corroded, and show signs of previous leaks. Water heater in garage looks like not be functional. A qualified plumber could replace the corroded connections.

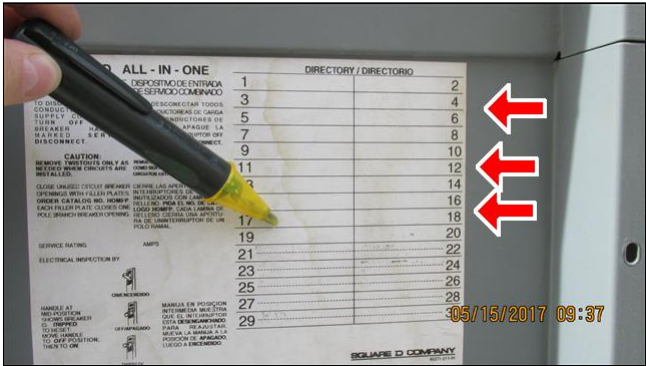
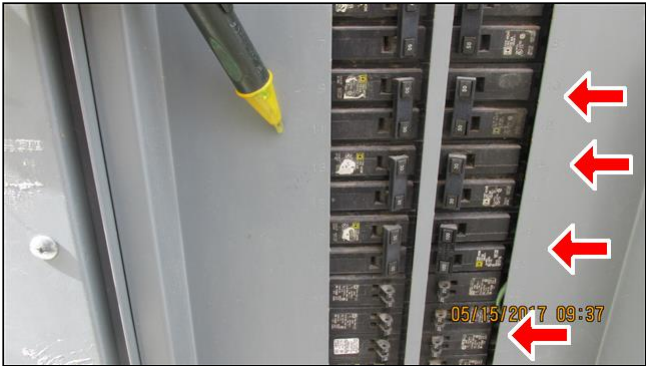
- (2) None of the breakers in the main service panel are labeled. Verifying that breaker amperage is correct for each circuit is beyond the scope of this inspection. All breakers should be correctly labeled.

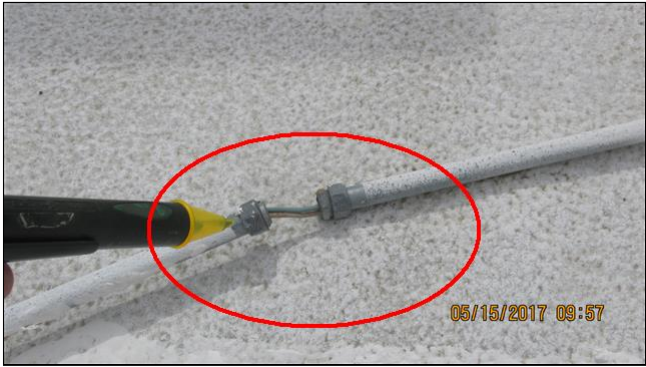
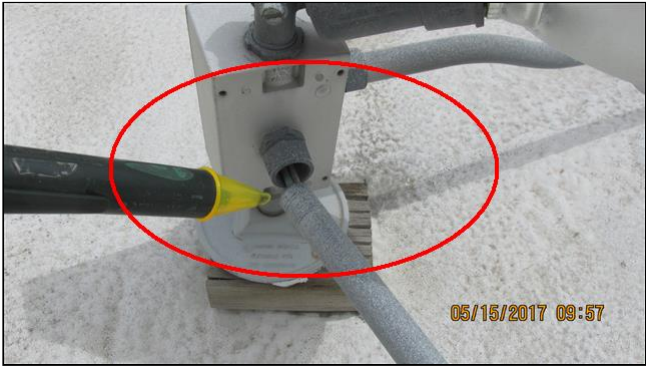
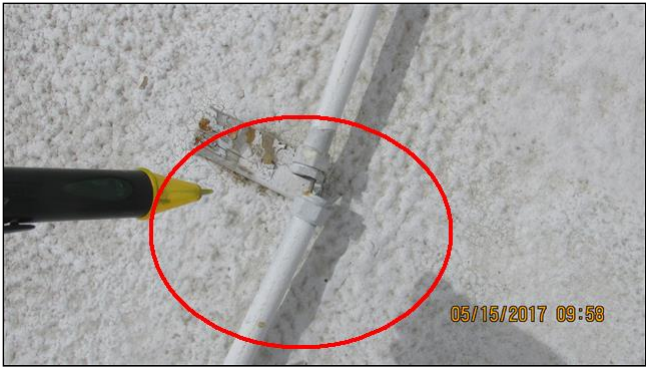
⊗ (2) There is an exposed wire in the several areas on the roof, we did not attempt to list every location. Exposed wire are a shock and fire hazard. Have a qualified electrician make further evaluations and repairs as needed.

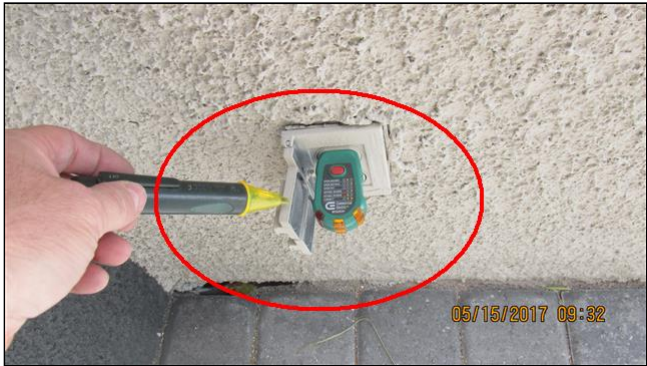
6.5 Item 1(Picture)

⊗ (1) Exterior receptacle(s) at the rear of the building has no power. A qualified technician could evaluate the receptacle and make repairs or modifications as necessary.

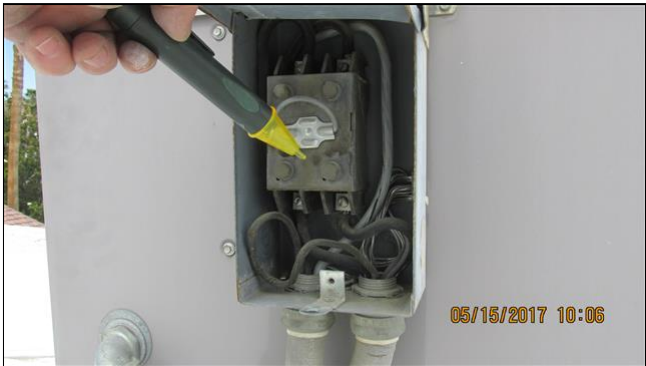
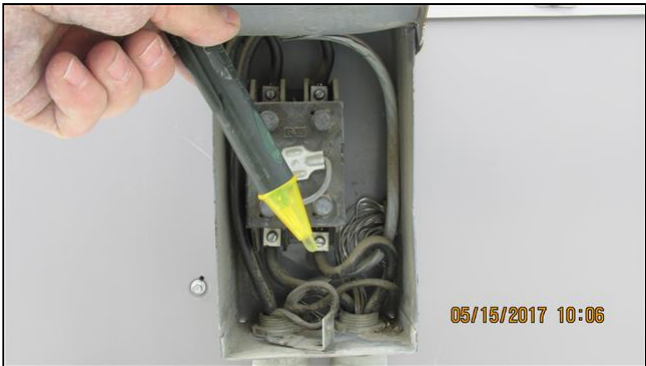
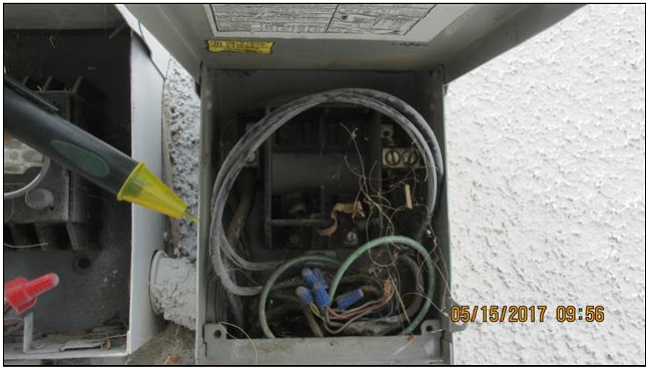
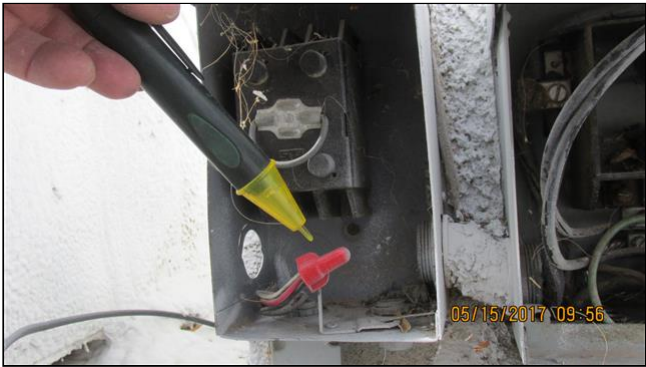
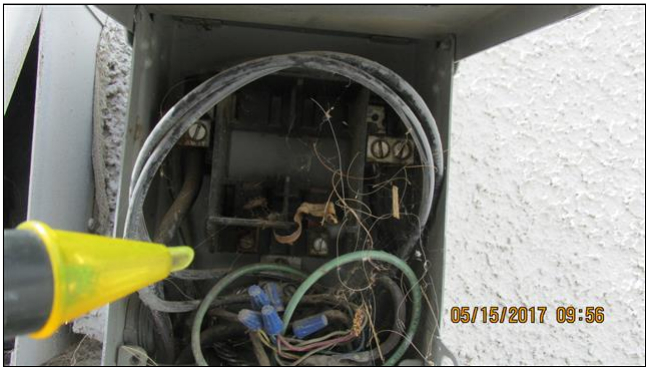
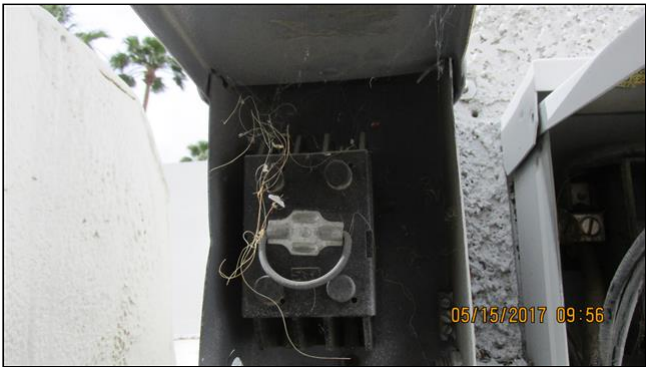
- ❌ (2) There is one or more openings in a outlet box where a twistout has been removed. A person could contact live electrical components in the box.  
We recommend A proper twistout cover should be installed in any opening. A qualified technician could do the work.

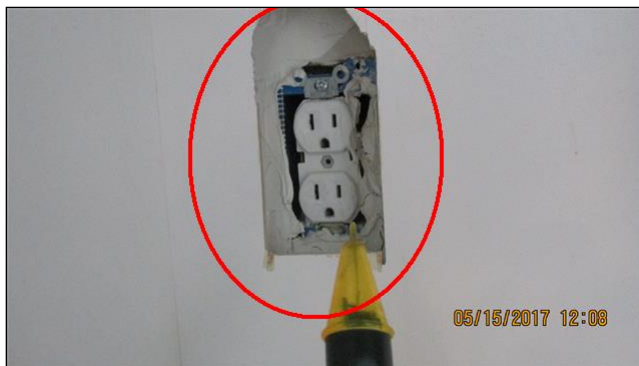
6.6 Item 2(Picture)

- ❌ (2) Electrical face plate/s are missing. This should be repaired as it poses and possible hazard. Simple repair

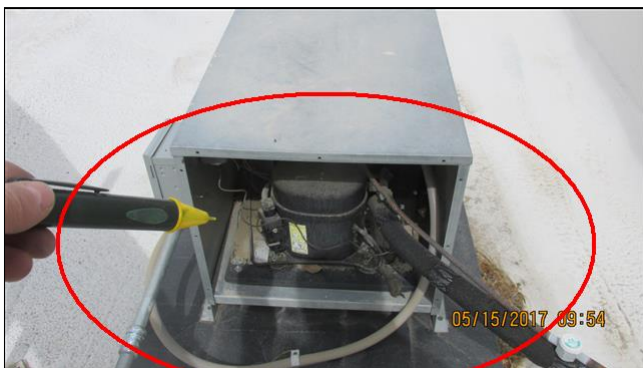
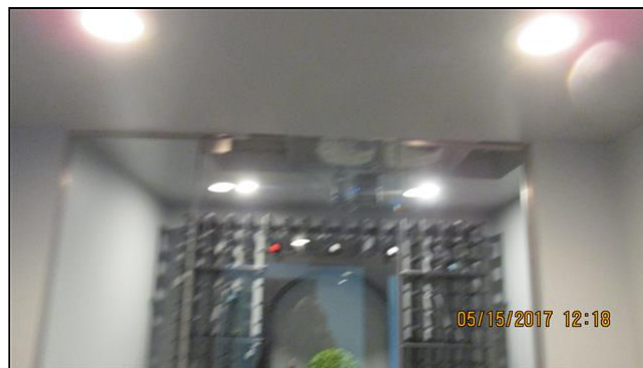
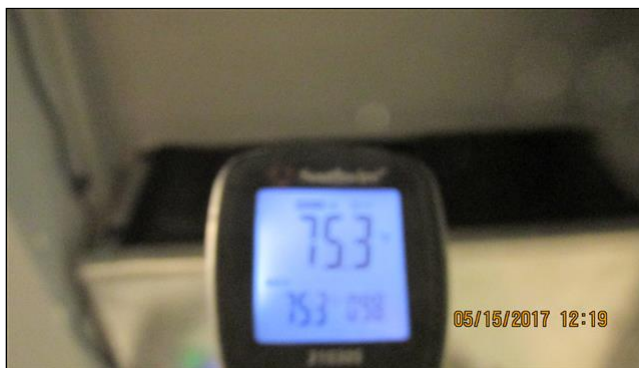
- ❌ (2) The door is loose /damaged / broken. This is a safety concern that should be repaired. This unit is for wine cooler and its not working proper way.

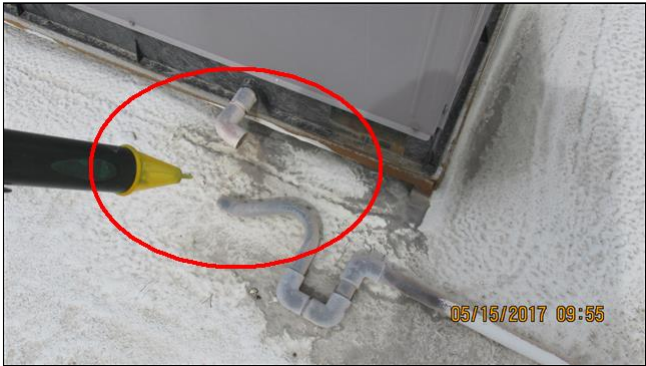
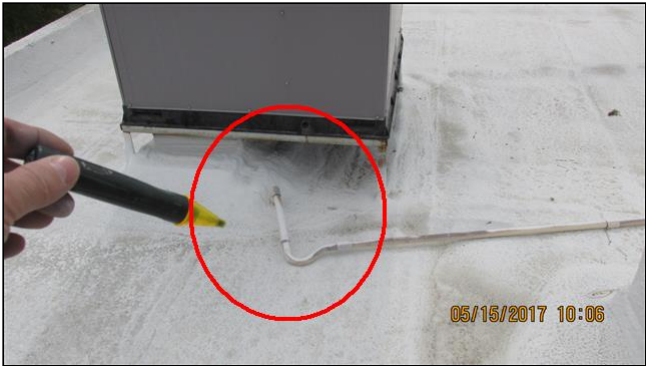
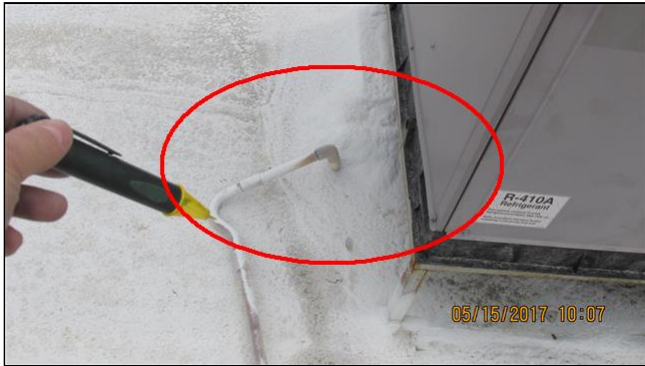
- ❌ (3) The condensate drain line for the air conditioner discharges on to the roof surface. This is improper and will lead to advanced deterioration of the roofing surface and lead to water ponding that can lead to water penetration. Recommend modifying the drain line to drain off the roof surface.

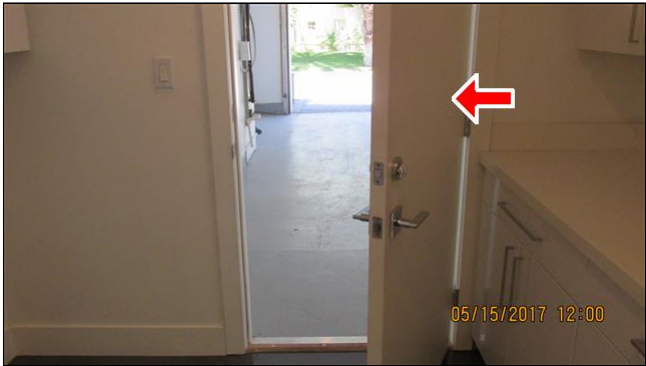
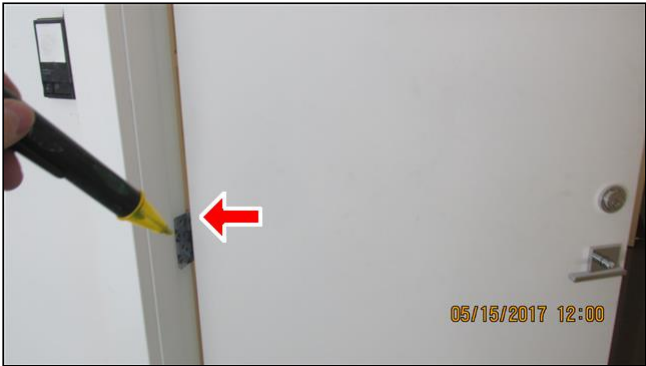
- ✗ The door between the garage and the living space is solid, but is not self-closing. A qualified technician should install an approved self-closing mechanism to ensure proper operation of the fire rated door.

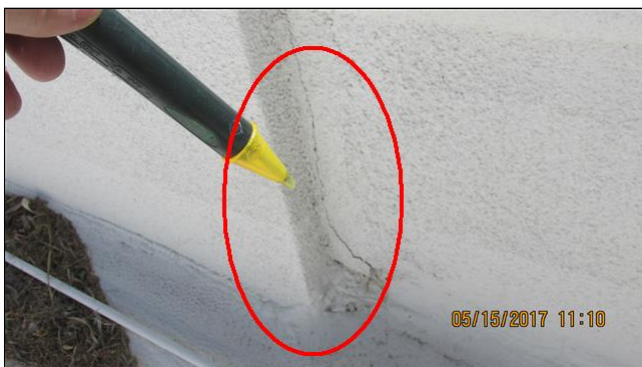
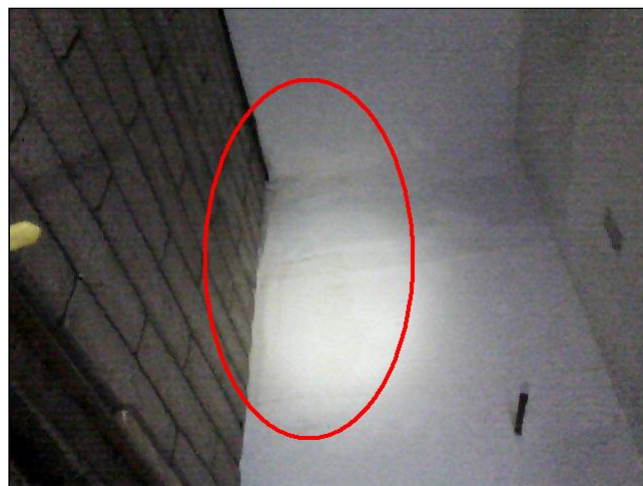
- ❌ (2) There are water stains on the exterior water heater closet ceiling, but we did not identify its source. Ask the owner to provide you with information about the leak(s), and what corrective action (if any) was taken to repair the leak(s). If this inquiry does not yield enough information, a qualified technician should evaluate the stained areas and make repairs or modifications as necessary.

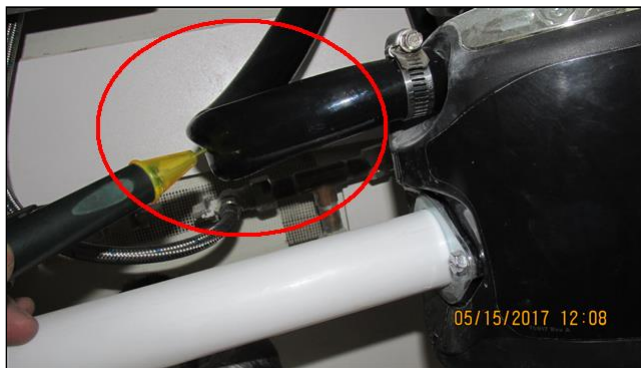
11.7 Item 3(Picture)

- ❌ (2) The air gap or its connection to the disposal is restricted or kinked. This causes water to flow out of the air-gap during the drain cycle of the dishwasher. The dishwasher drain system should be cleaned or modified to restore proper operation. A qualified technician could do the work.

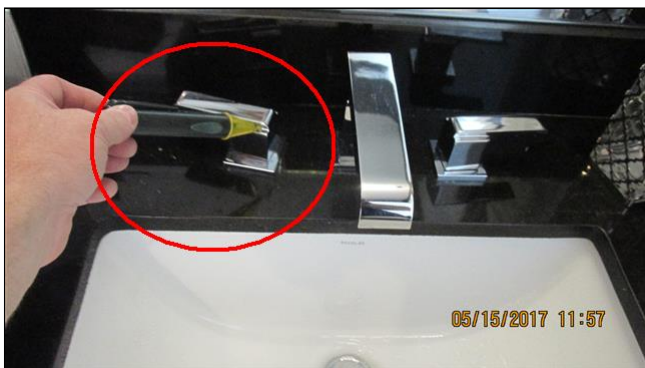
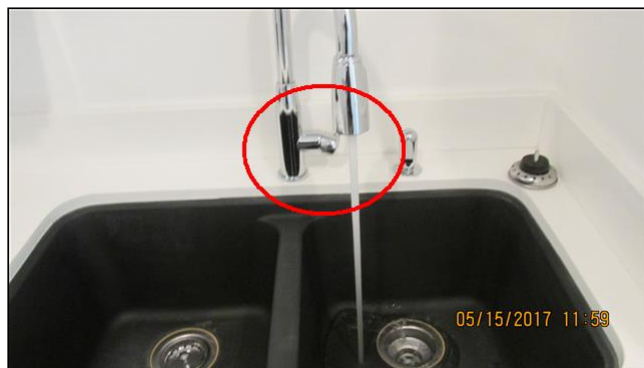
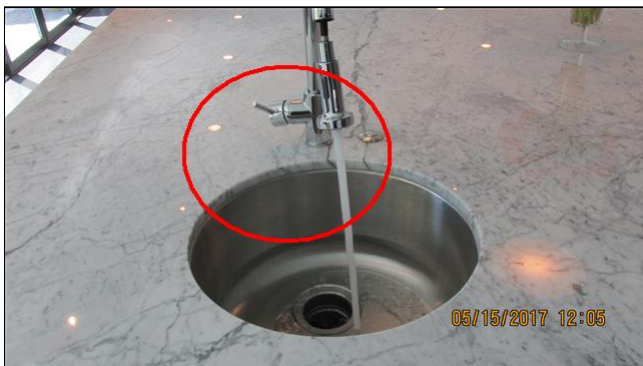
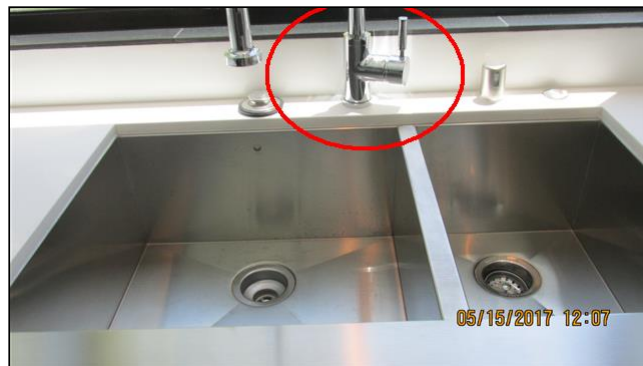
- ❌ (4) The Kitchen sink, Island Sink, guest bathroom and laundry room faucet is supplying only Cold water and needs repair. I suggest a Professional Plumber be consulted.

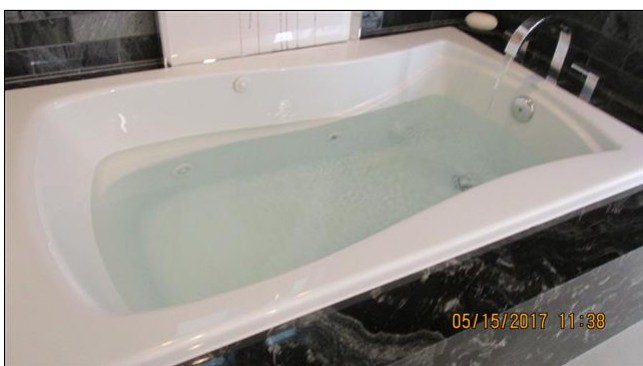
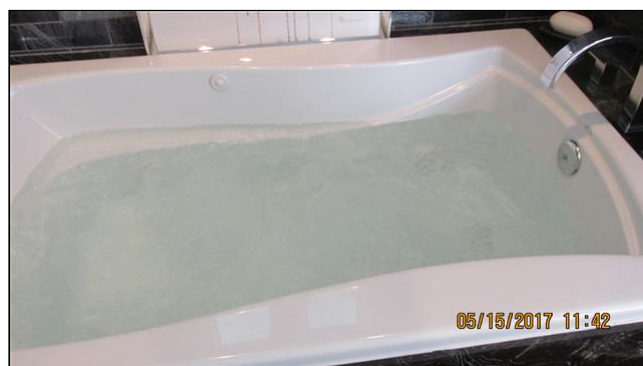
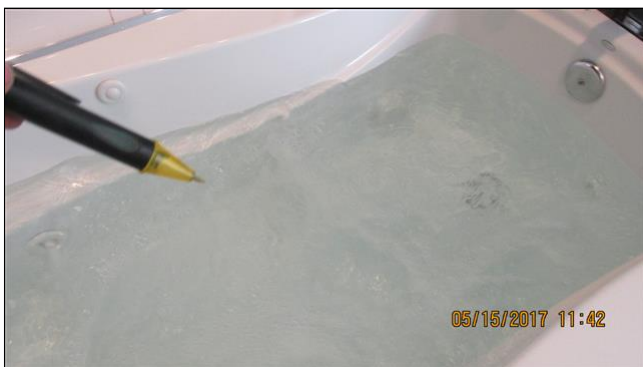
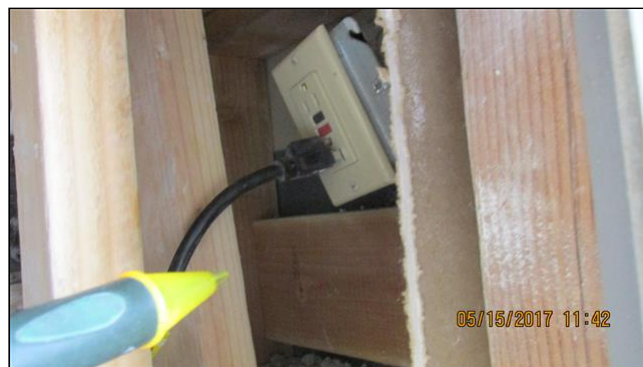
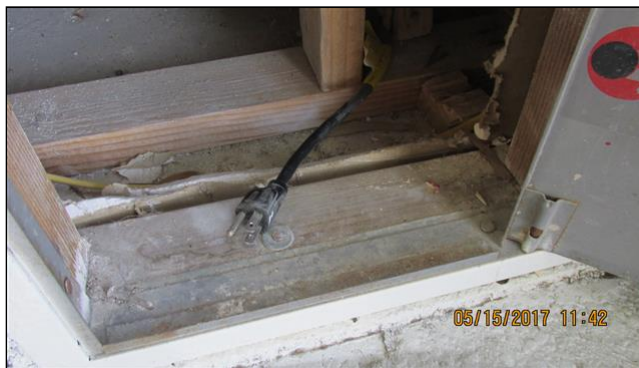
The whirlpool tub is not functional. A qualified technician should evaluate the system and make repairs or modifications as necessary.

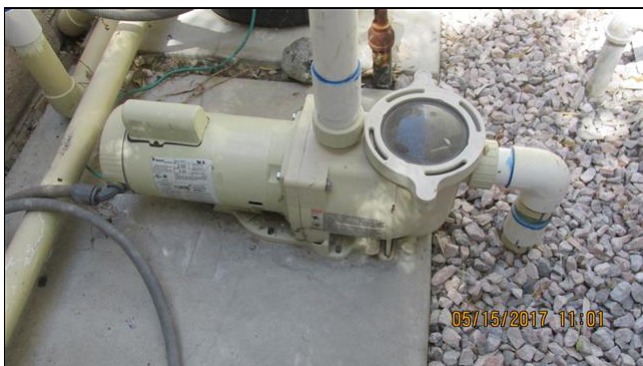
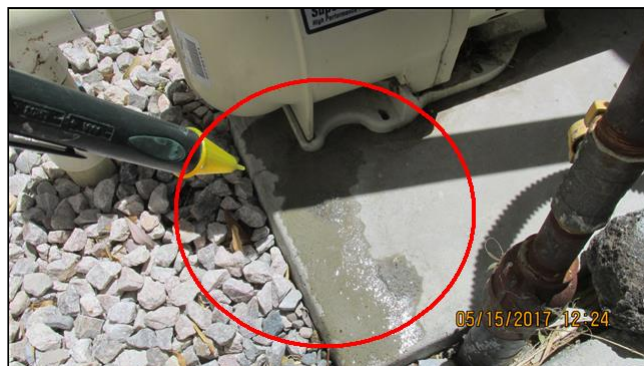
- ☒ There are water leaks at the pump. A qualified technician should make repairs or modifications as necessary.

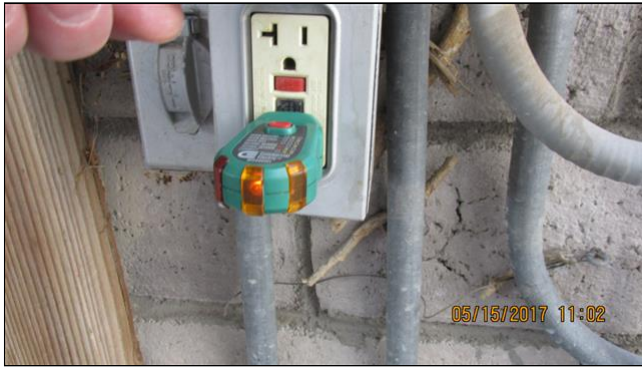
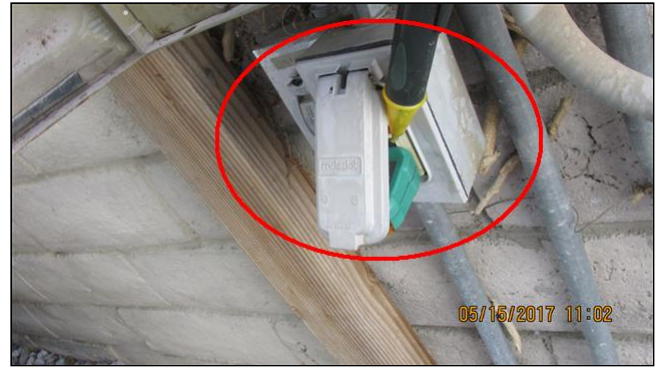
- ☒ (1) The GFCI circuit installed to protect the pool light is not functional (did not trip when tested) and needs replacement.

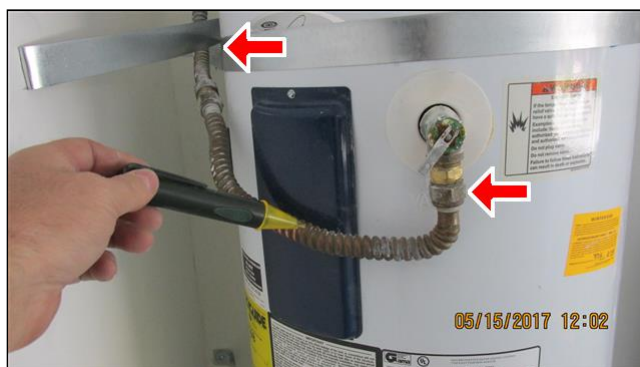
5.7 Item 10(Picture)

(3) The T & P discharge pipe does not drain downward as the valve manufacturer specifies. This can promote premature failure of the valve, and a defective valve is unsafe. Installing a down-pointing pipe route for water heaters located in basements or other interior areas can be difficult, but is the only solution that complies with valve installation specifications. While a valve and pipe that empties on the floor can create a water problem if it activates, such an installation is more likely to operate safely. Some local authorities will permit an upward section of pipe providing a manual drain is installed at the bottom of the vertical pipe section.

A qualified plumber can reroute the pipe where the water heater location permits, or install a manual drain valve for periodic maintenance.

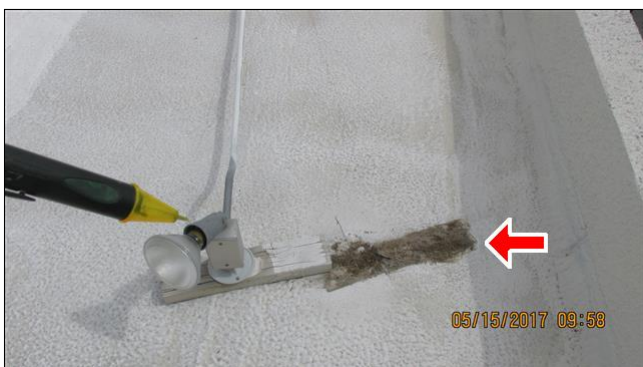
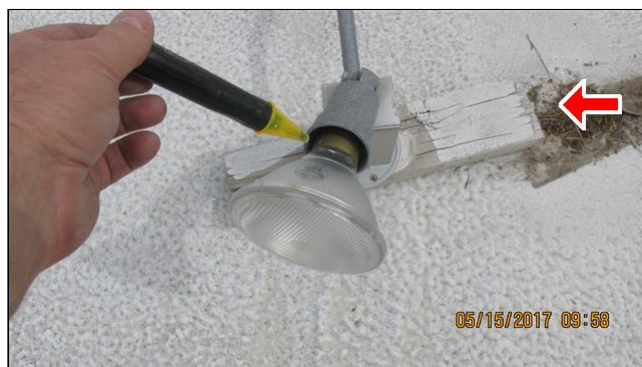
- ⏏ (3) One or more exterior light fixtures are loose and or not securely fastened to the building. This could result in stress on the wiring systems and should be repaired. A qualified contractor could secure any loose fixtures.

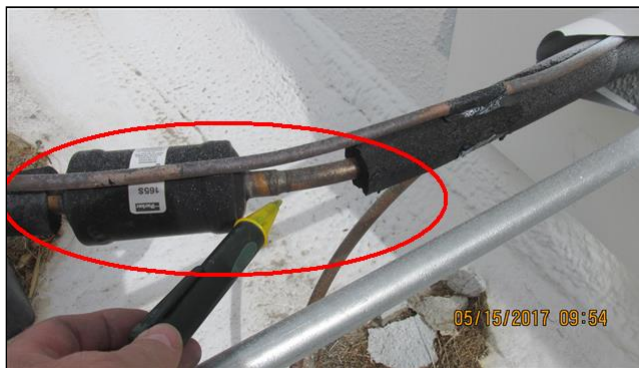
7.4 Item 7(Picture)

- ⏏ (2) The insulation on the refrigerant (coolant) lines is missing outside near the condenser(s). Missing insulation on refrigerant (coolant) lines can cause energy loss and condensation. I recommend having a handy person install insulation in areas where it is missing.

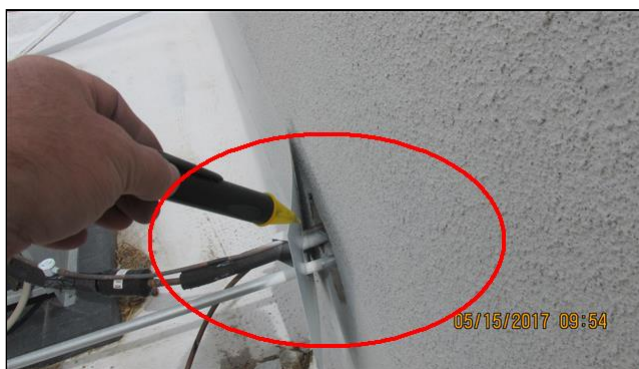
7.4 Item 11(Picture)

(4) The penetration(s) where the coolant refrigerant lines enter the building is not sealed. This area is large enough to allow pests to enter the building. A handy person should seal the penetration.

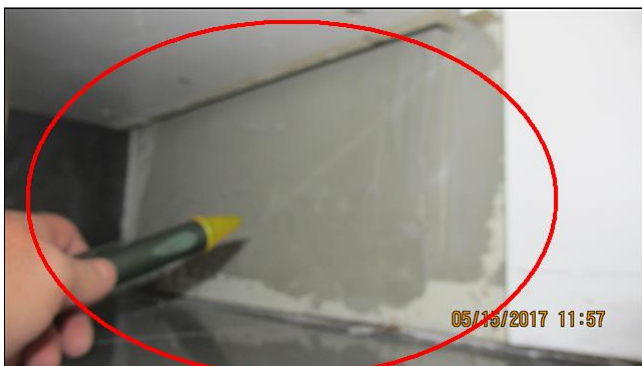
10.2 Item 1(Picture)

(2) Some items relating to the finished surfaces, trim, hardware, etc. have been removed. All removed items should be replaced to restore acceptable appearance and function.

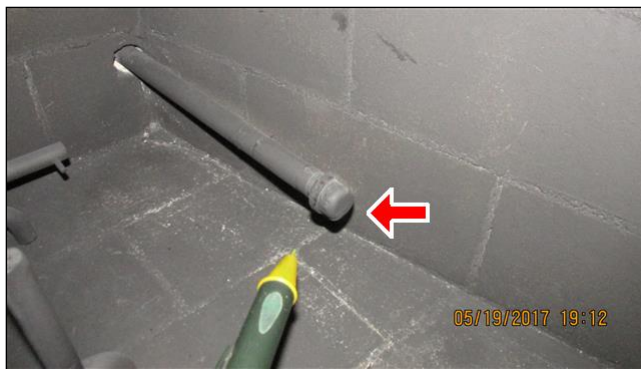
10.7 Item 3(Picture)

(2) No gas service. Fireplace not tested. You should verify normal operation prior to closing date.

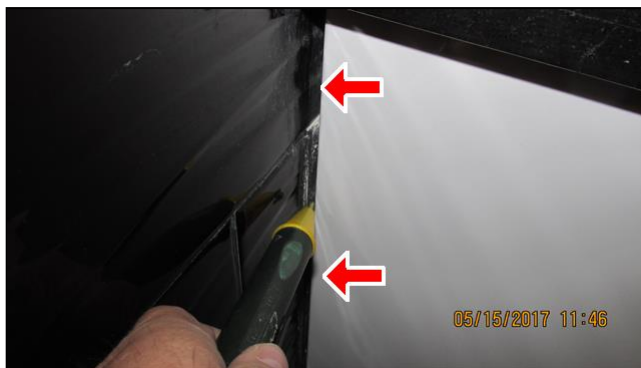
12.2 Item 5(Picture)

(2) The vanity in the first floor guest bathroom is not secured to the wall. This can lead to damaged and/or leaking plumbing as a result of movement. The cabinet should be re-secured in position against the wall.
