NEVADA PROPERTY CONCEPTS

Inspection Report

Property Address:
2870 Augusta Dr.
Las Vegas NV 89109

Date: 5/15/2017	Time: 09:00 AM	Report ID: 20170515-09.00SP
Property: 2870 Augusta Dr. Las Vegas NV 89109	Customer: Mr. Phil Edgar	Real Estate Professional: Jamie Tsai O' Harmony Realty LLC.

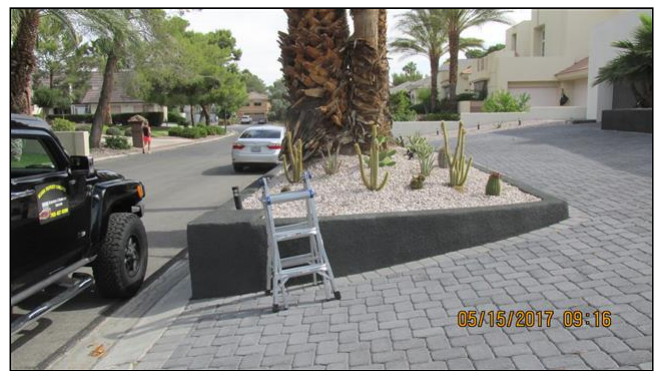
3.2 Item 1(Picture)

(1) The vegetation at the time of the inspection was a prudent distance from the structure. Be sure to keep all vegetation away from the structure in order to help prevent moisture and or pest issues.

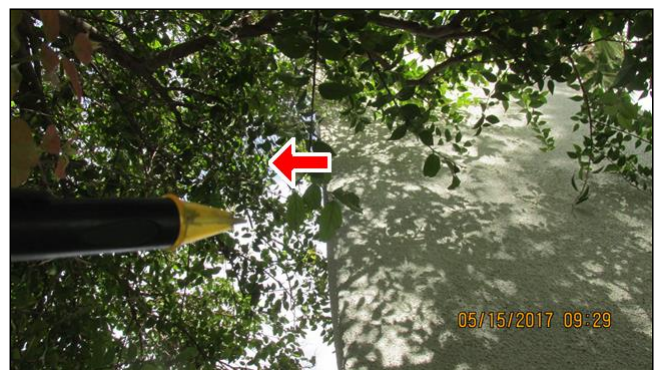
3.2 Item 2(Picture)

☒ (2) At time of inspection, one or more areas of the vegetation were observed to be against or close to the exterior walls. This should also be noted on your WDO (Termite) report. Irrigated vegetation against house walls is conducive to Subterranean Termites.

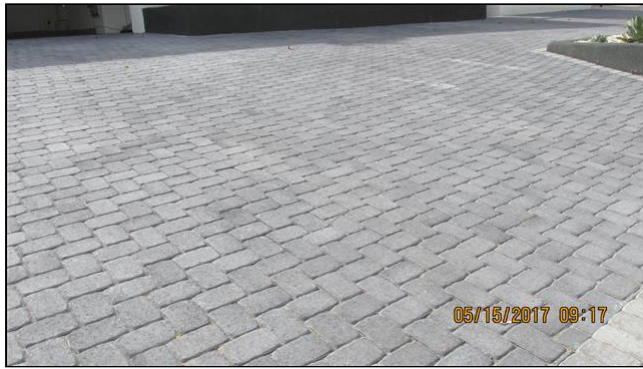
3.3 Item 1(Picture)

(1) Except for typical hairline cracks, the driveway, walkways and patio(s) showed no visible signs of any deficiencies on the day of the inspection.

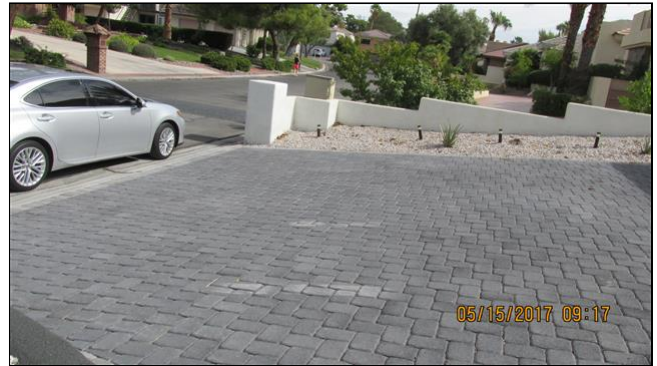
3.3 Item 4(Picture)

- ☒ (2) One or more areas of the stone masonry at the front of the home are loose / lifted and has created a trip hazard. A qualified mason can make repairs.

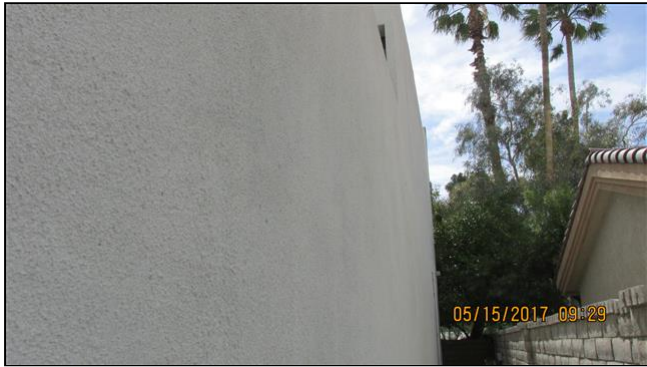
3.8 Item 1(Picture)

Comments: Inspected
(1) No significant defects were observed during the inspection with the stucco and or hybrid stucco material.

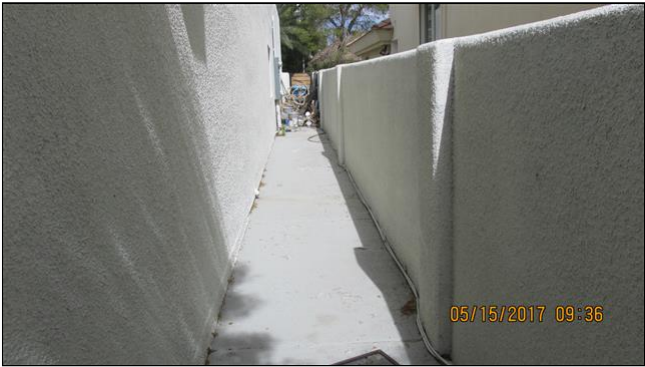
3.8 Item 2(Picture)

❌ (2) One or more areas of stucco cladding on a flat surface were observed on this home. Cracks requiring repair were noted. All areas of flat stucco cladding with cracks of any size should be repaired as needed.

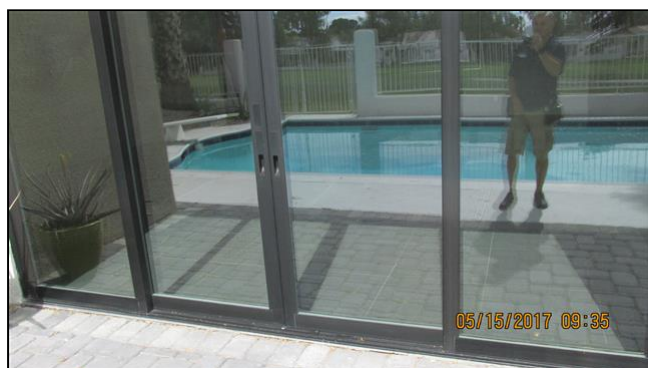
3.9 Item 1(Picture)

The exterior doors showed no signs of any defects on the day of the inspection.

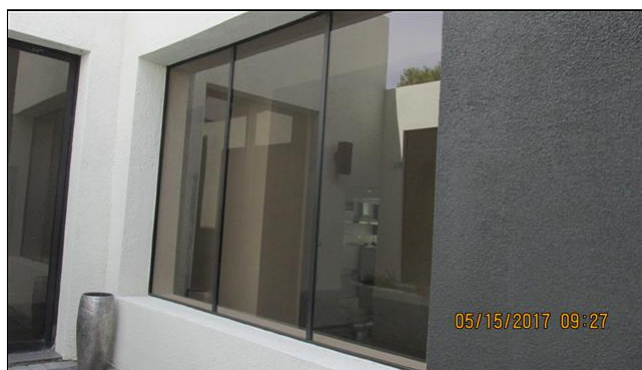
3.10 Item 1(Picture)

The exterior side of the windows showed no signs of any deficiencies on the day of the inspection.

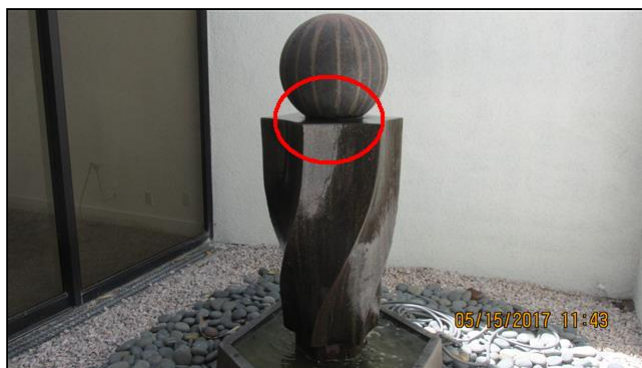
3.11 Item 1(Picture)

- ☒ The fountain components are not secured together. This is a potential child safety concern. Securing the fountain is recommended. A qualified trades person could do the work.

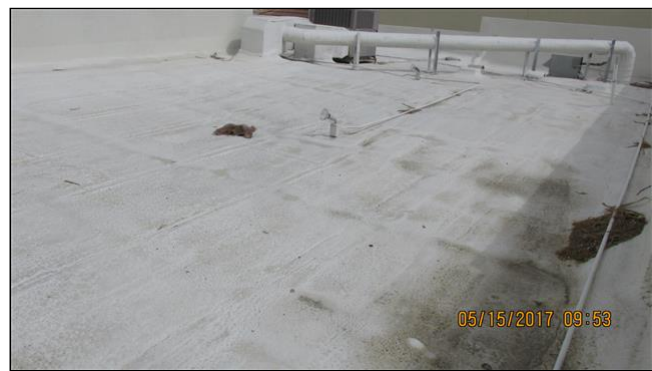
4.2 Item 1(Picture)

Comments: Inspected
(1) Polyurethane foam roof with an elastomeric covering. Foam roofs consist of a layer of sprayed-on urethrae foam, usually several inches thick, covered with a coating for protection against the UV radiation of the sun. The foam can be very durable if the coating is properly maintained. Typical life spans for this type roof are between fifteen and twenty-two years. Flat and/or gradual sloped construction. The roof appears to be in the last third of its useful life. Periodic maintenance will extend the life of the roof for some time yet. Suggest routine maintenance of reapplying the elastomeric covering to prolong the life of the roof.

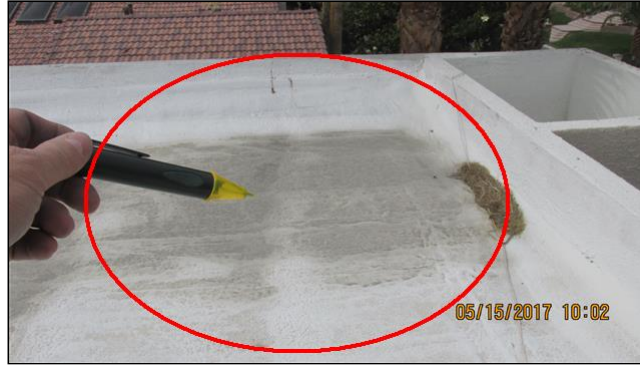
4.2 Item 2(Picture)

- ❌ (2) While some "ponding" is typical for all flat roof covers this roof exhibits excessive areas of ponding and deterioration. This roof should be evaluated by a qualified contractor.

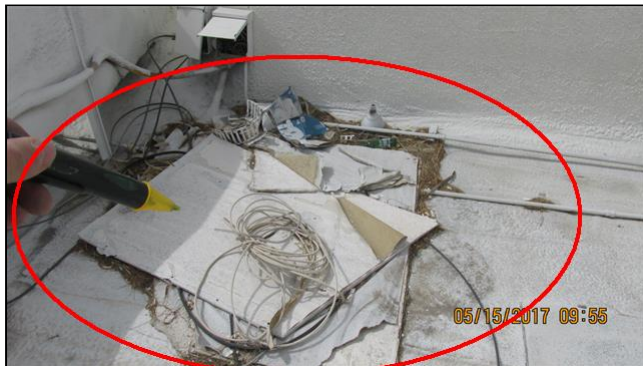
4.2 Item 4(Picture)

- ❌ (4) There is non typical material stored on the roof surface. This can damage the roof surface and/or shorten the life of the underlying roofing. Recommend removal of the stored items.

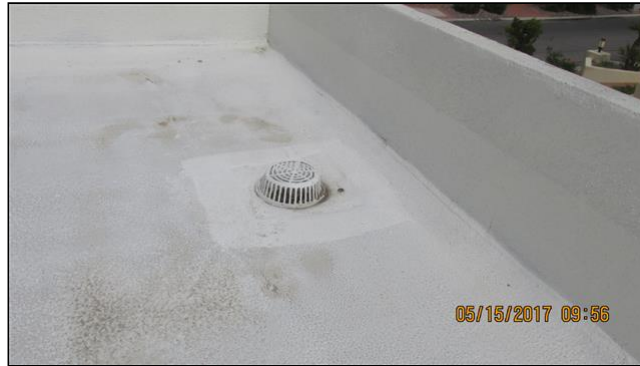
4.3 Item 1(Picture)

All visible flashing materials showed no signs of any deficiencies on the day of the inspection.

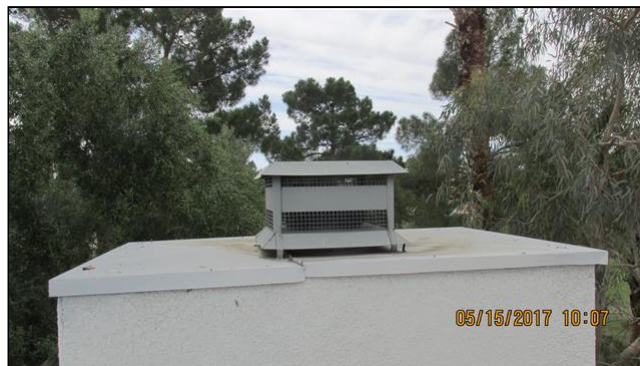
4.4 Item 1(Picture)

(1) The Chimney(s) was observed to be intact and functional at time of inspection.

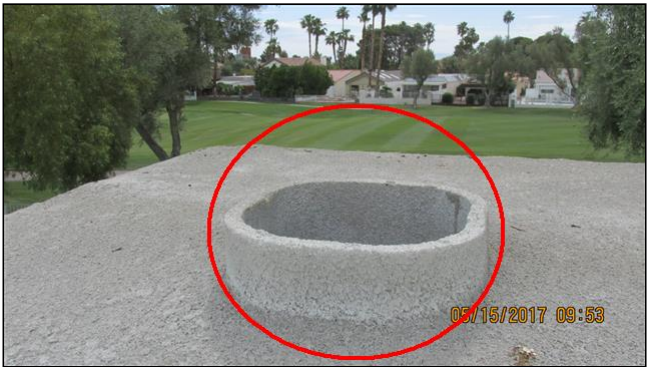
4.4 Item 2(Picture)

- ❌ (2) No spark arrestor or rain cap is installed at the chimney flue terminal. Caps help prevent the escape of hot embers or rain entry. As an upgrade, a combination chimney cap/spark arrestor should be installed.

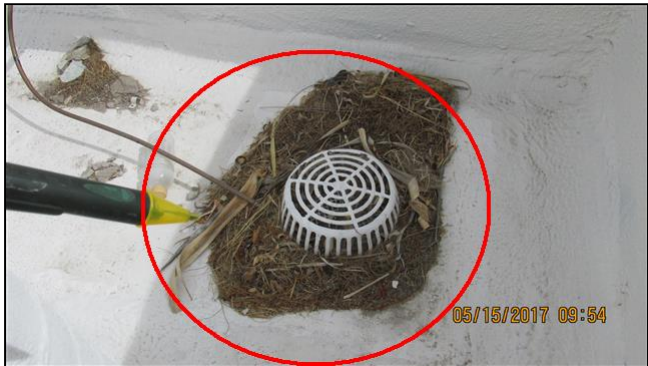
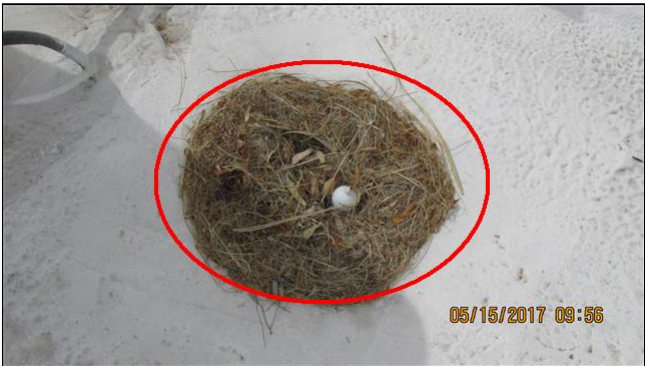
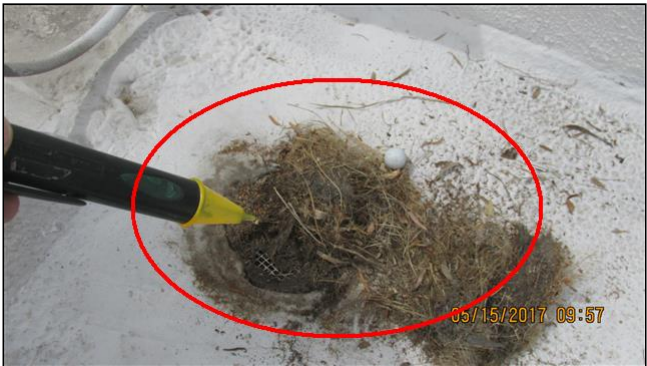
- ❌ A section of the internal roof drains are clogged with debris, and are not draining as intended.
- SUGGESTION: All debris should be cleared from the roof drains, and the drains should be tested to ensure proper function.

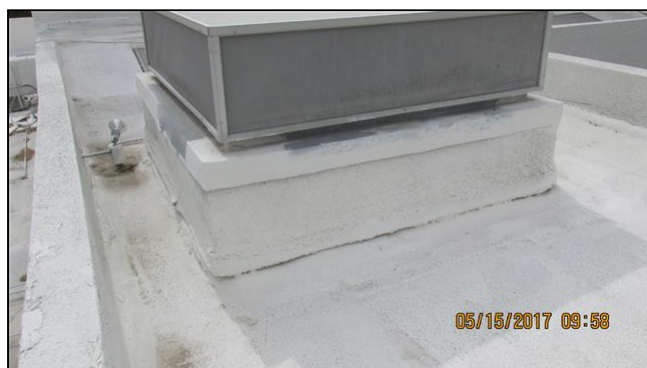
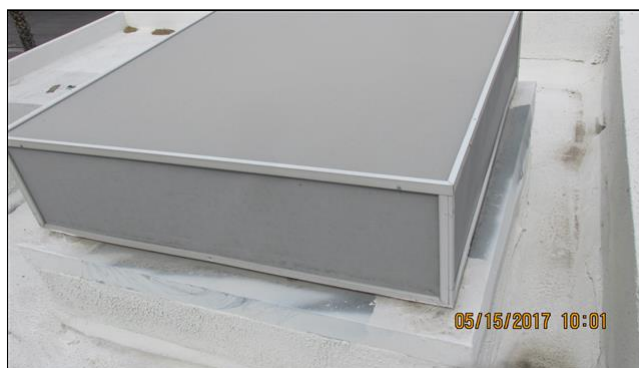
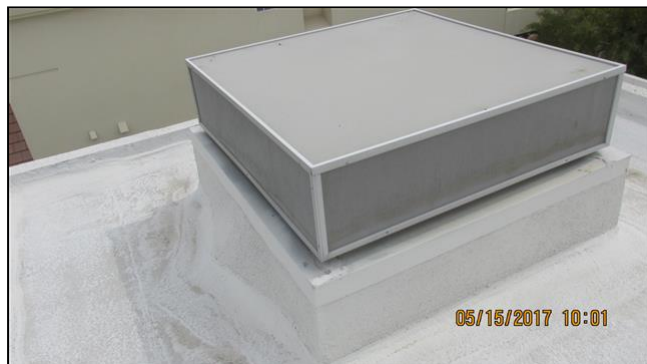
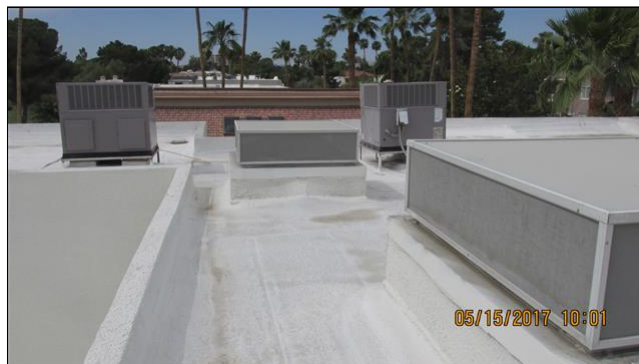
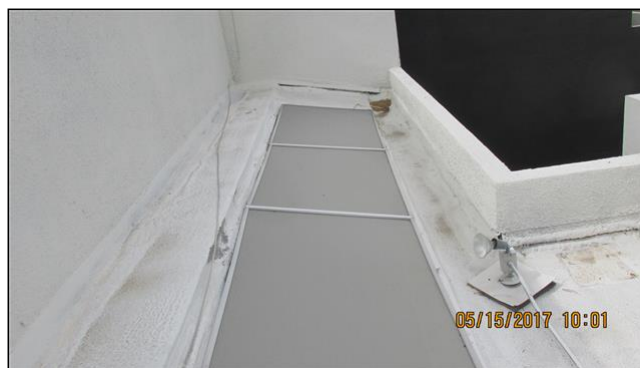
The skylights were intact and showed no visible deficiencies on the day of the inspection.

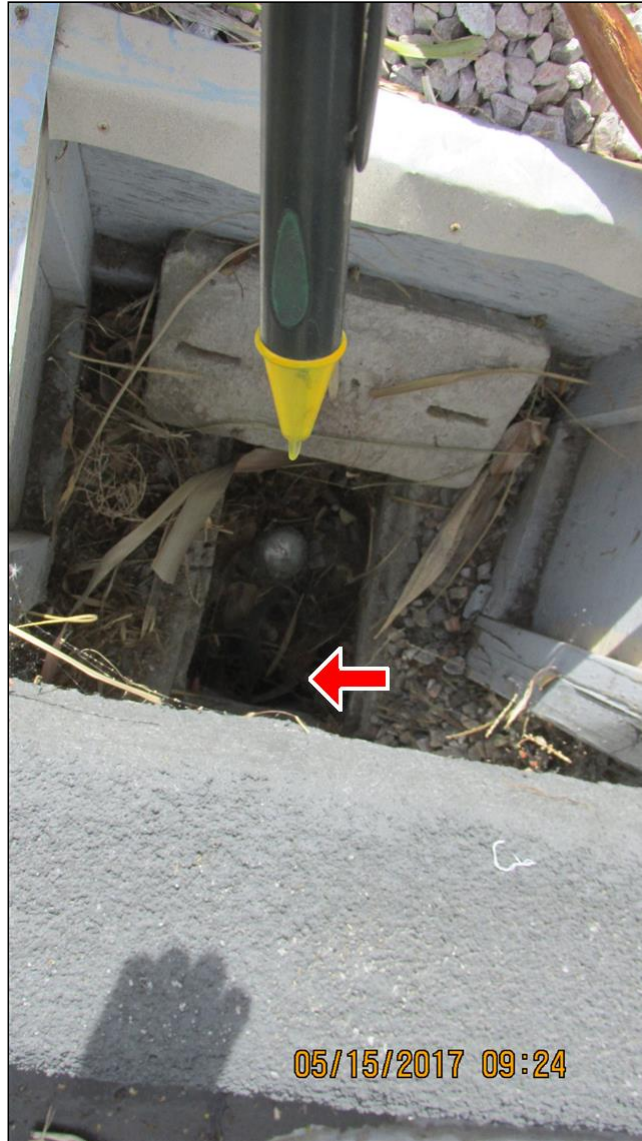
5.2 Item 1(Picture)

- ☒ When the water is shut off at all the fixtures inside the home the water meter was not turning. This generally indicates that there are no active water leaks. The water meter was turning even though water in the home was shut off. There is a leak/s that need to be repaired.

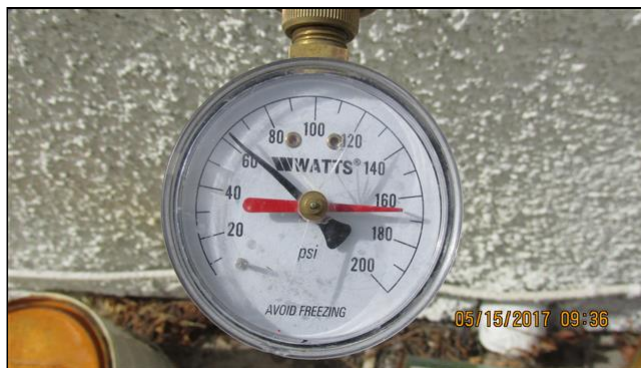
5.3 Item 1(Picture)

(1) No defects were observed for the water supply piping as identified in the Styles & Materials section. The flow was acceptable,

As best we can determine, this home has copper plumbing where the supply lines can be viewed. However, most homes with a post tension slab such as this will be fitted with plastic piping run between the floors (or attic if 1 story) and not under the slab as is commonly done with copper pipe. PEX plastic pipe will typically have some free play or movement when the piping is manipulated at the angle stops. This piping seemed rigid when manipulated indicating copper is present. Type and Manufacture of water piping used inside the home could not be determined as there was none of the piping exposed to view.

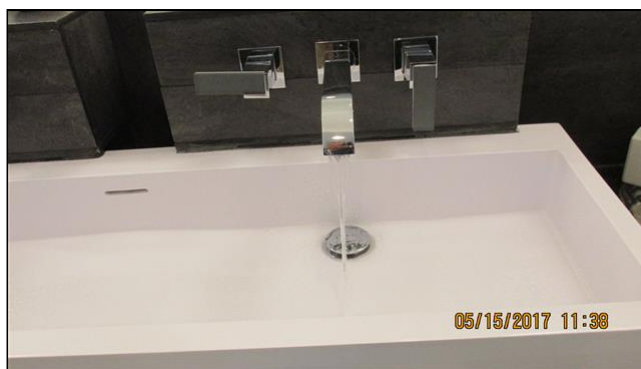
5.4 Item 1(Picture)

- (1) The accessible fixtures and faucets showed no visible defects during the inspection.

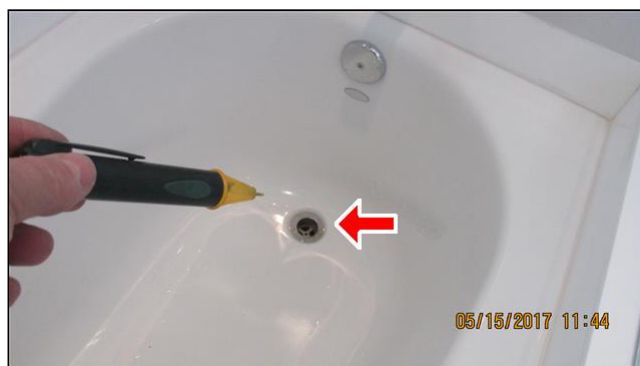
5.4 Item 2(Picture)

- ☒ (2) The aerator is missing on the faucet in the first floor guest bathroom. All missing aerators should be replaced.

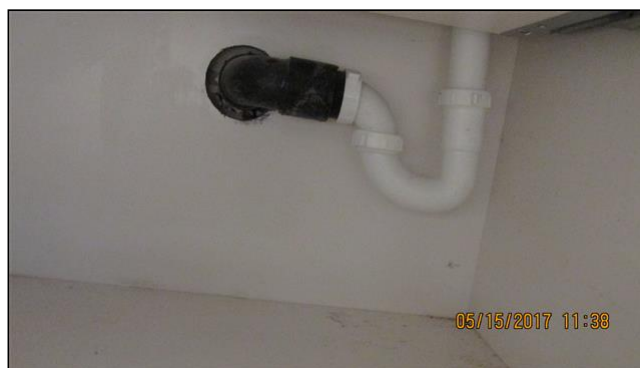
5.5 Item 1(Picture)

The drain / waste / vent piping as described in the Styles & Material section showed no defects during the inspection.

NOTE: This statement applies to the visible areas only.

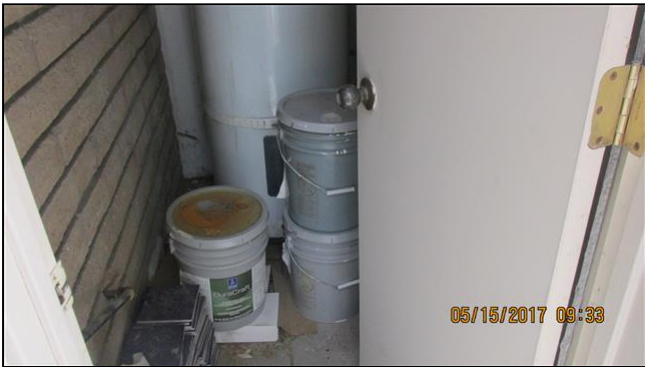
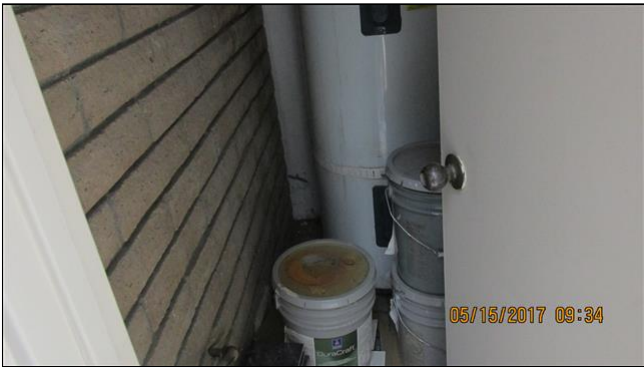
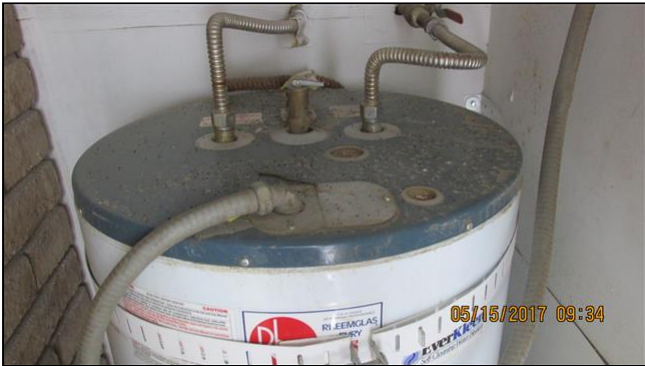
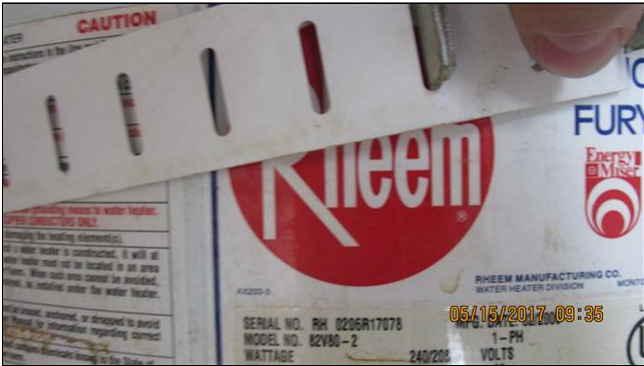
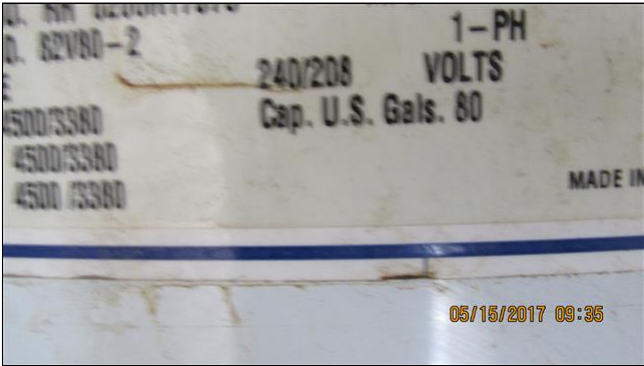
(1) The water heater performed it's intended function, and showed no signs of leaking and or distress, on the day of the inspection.

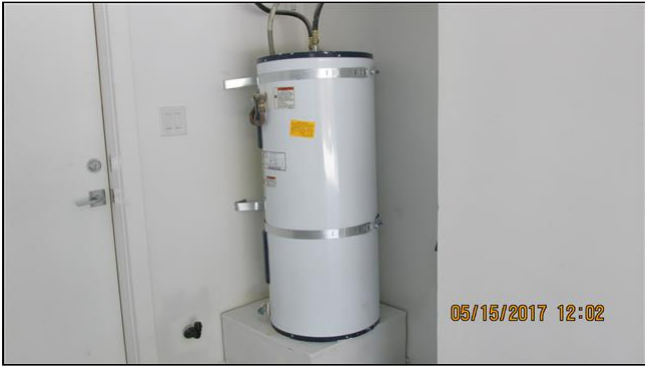
5.7 Item 7(Picture)

☒ (2) The water connections are heavily corroded, and show signs of previous leaks. Water heater in garage looks like not be functional. A qualified plumber could replace the corroded connections.

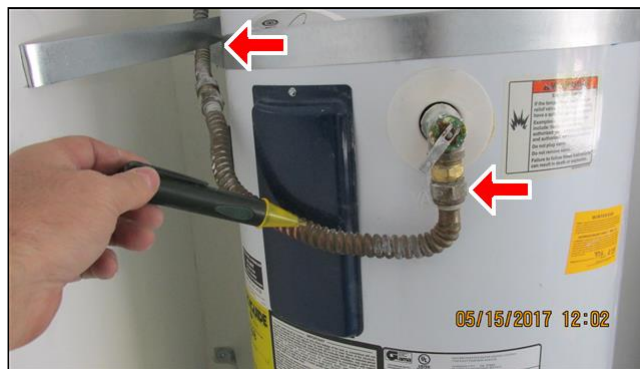
5.7 Item 10(Picture)

- ☒ (3) The T & P discharge pipe does not drain downward as the valve manufacturer specifies. This can promote premature failure of the valve, and a defective valve is unsafe. Installing a down-pointing pipe route for water heaters located in basements or other interior areas can be difficult, but is the only solution that complies with valve installation specifications. While a valve and pipe that empties on the floor can create a water problem if it activates, such an installation is more likely to operate safely. Some local authorities will permit an upward section of pipe providing a manual drain is installed at the bottom of the vertical pipe section.

A qualified plumber can reroute the pipe where the water heater location permits, or install a manual drain valve for periodic maintenance.

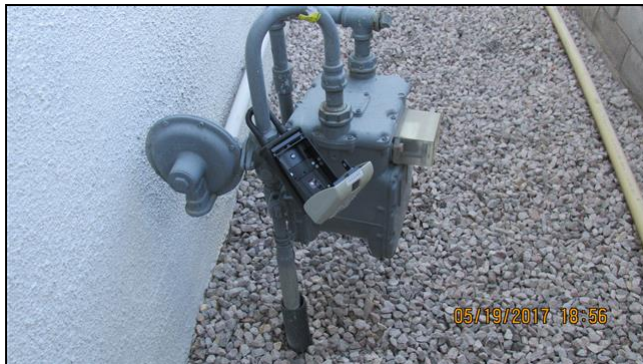
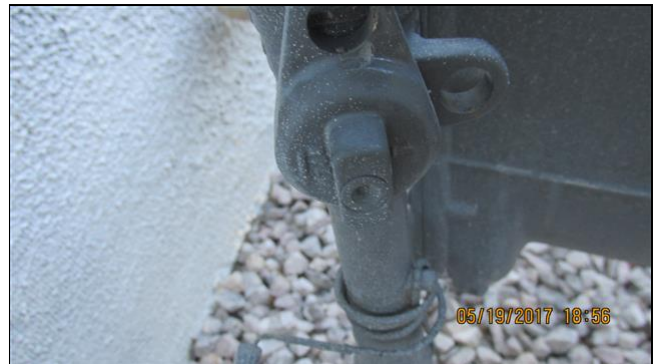
The gas meter and visible piping material displayed no visible signs of any deterioration, and or leaking. Leak detection was performed using our sense of smell trying to detect the sulphur product added to natural gas.

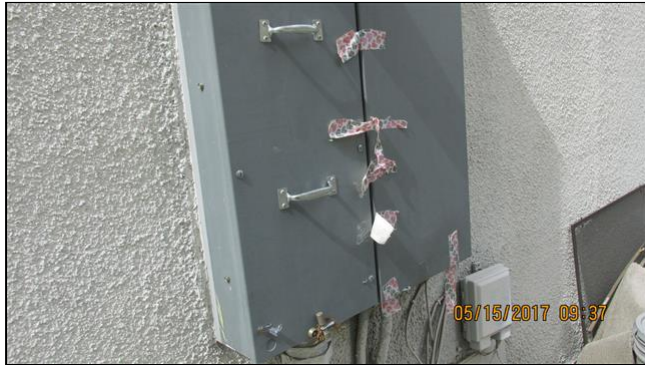
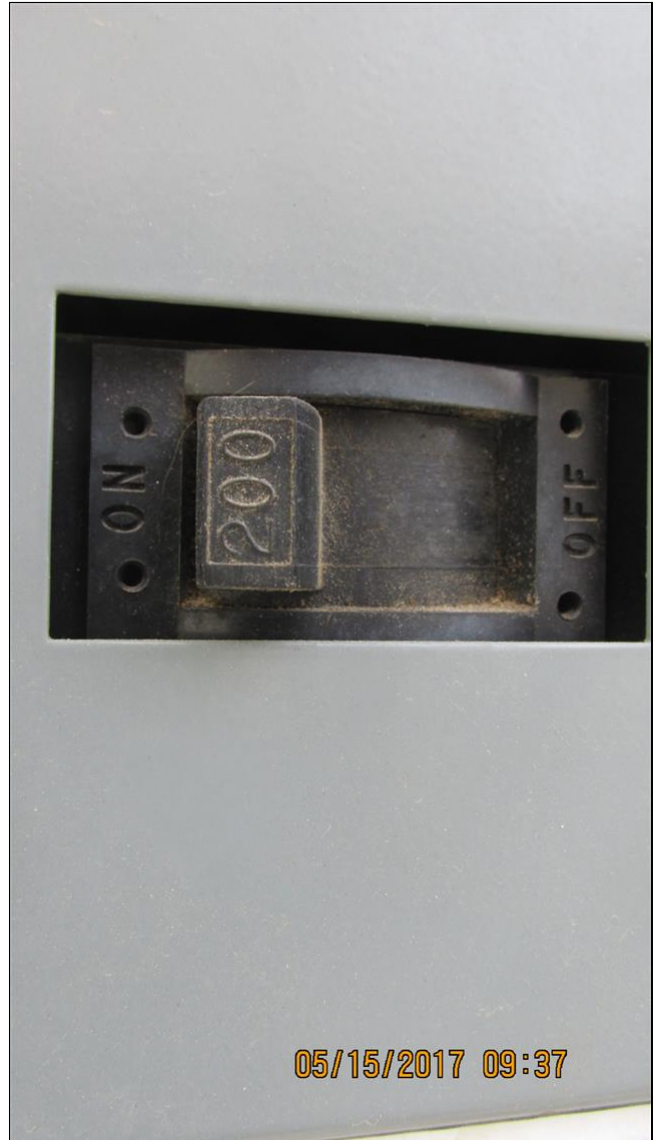
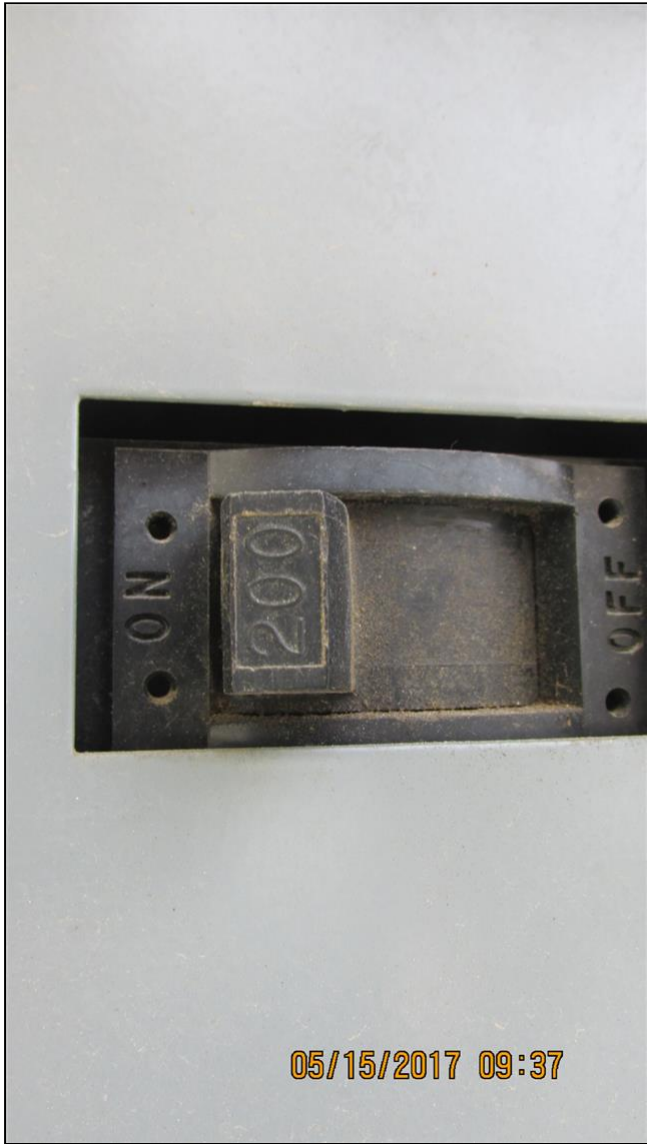
(1) No deficiencies were noted on the day of the inspection.

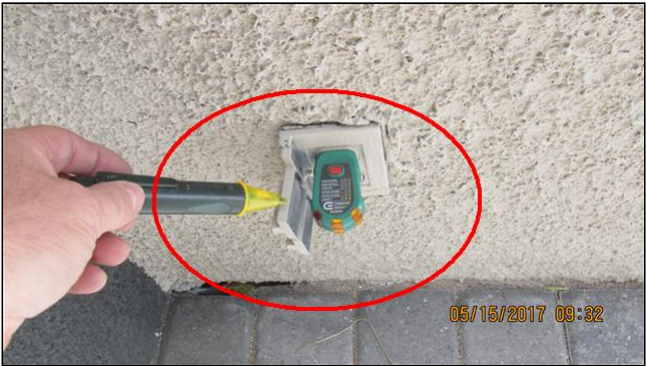
6.5 Item 1(Picture)

⊠ (1) Exterior receptacle(s) at the rear of the building has no power. A qualified technician could evaluate the receptacle and make repairs or modifications as necessary.

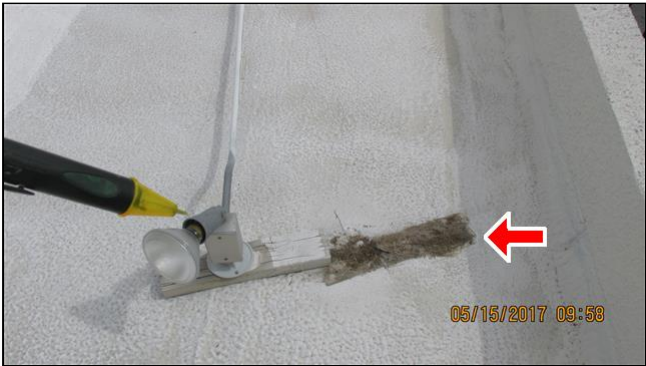
6.5 Item 8(Picture)

- 🔧 (3) One or more exterior light fixtures are loose and or not securely fastened to the building. This could result in stress on the wiring systems and should be repaired. A qualified contractor could secure any loose fixtures.

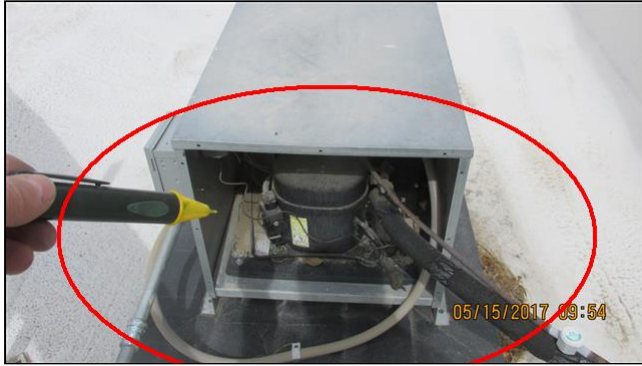
7.3 Item 9(Picture)

- ☒ (2) The door is loose /damaged / broken. This is a safety concern that should be repaired. This unit is for wine cooler and its not working proper way.

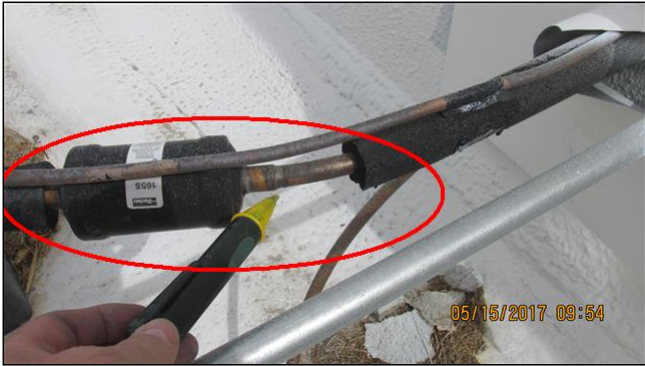
7.4 Item 7(Picture)

☒ (2) The insulation on the refrigerant (coolant) lines is missing outside near the condenser(s). Missing insulation on refrigerant (coolant) lines can cause energy loss and condensation. I recommend having a handy person install insulation in areas were it is missing.

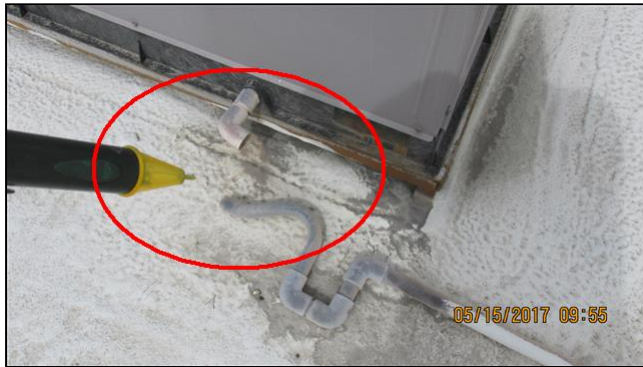
7.4 Item 8(Picture)

- ❌ (3) The condensate drain line for the air conditioner discharges on to the roof surface. This is improper and will lead to advanced deterioration of the roofing surface and lead to water ponding that can lead to water penetration. Recommend modifying the drain line to drain off the roof surface.

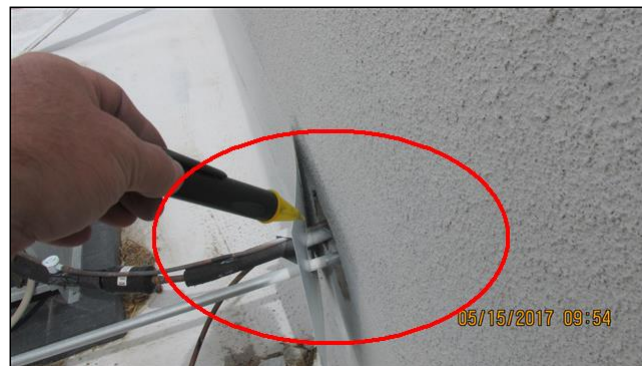
7.4 Item 11(Picture)

- ⚠️ (4) The penetration(s) where the coolant refrigerant lines enter the building is not sealed. This area is large enough to allow pests to enter the building. A handy person should seal the penetration.

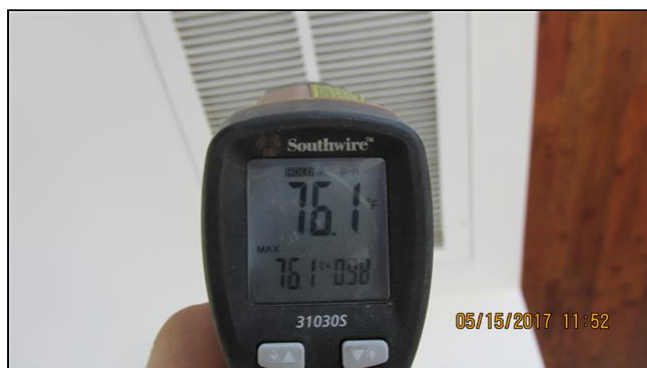
7.5 Item 1(Picture)

The ambient air test was performed by using thermometers on the air handler of air conditioner to determine if the difference in temperatures of the supply and return air are between 17 degrees and 22 degrees which indicates that the unit is cooling as intended. The supply air temperature on your system read 57 degrees, and the return air temperature was 76 degrees. This indicates **the range in temperature drop is normal.**

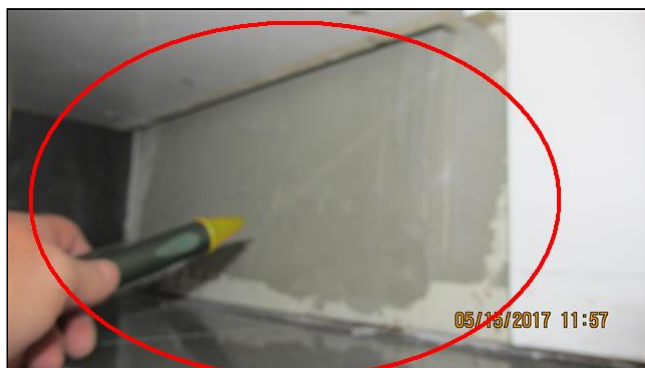
10.2 Item 1(Picture)

(2) Some items relating to the finished surfaces, trim, hardware, etc. have been removed. All removed items should be replaced to restore acceptable appearance and function.

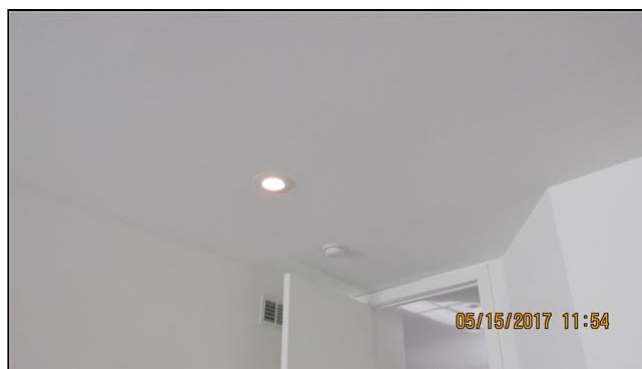
10.3 Item 2(Picture)

(1) Minor cracks are evident in the walls and/or ceilings. This is a common condition with this type of construction and, in this case, does not indicate any structural concerns.

The cracks can be repaired or painted during routine maintenance. Other than these cosmetic issues the walls were in acceptable condition

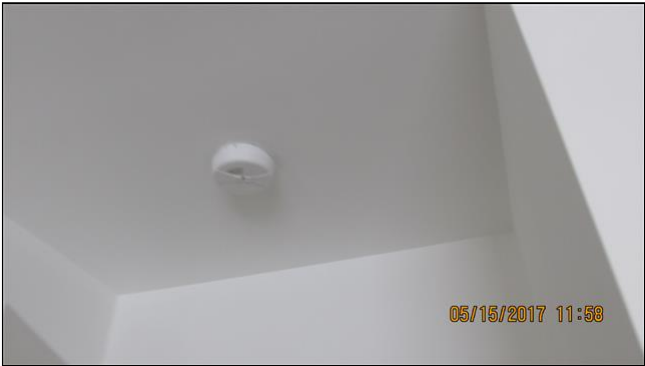
10.6 Item 1(Picture)

(1) The smoke detector(s) were inspected for location only. For future reference, testing with only the built-in test button verifies proper battery and horn function, but does not test the smoke sensor. We advise testing with simulated smoke upon occupying the building.

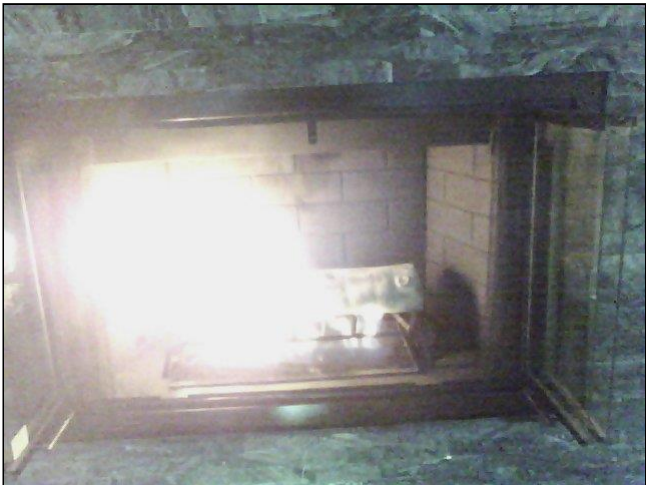
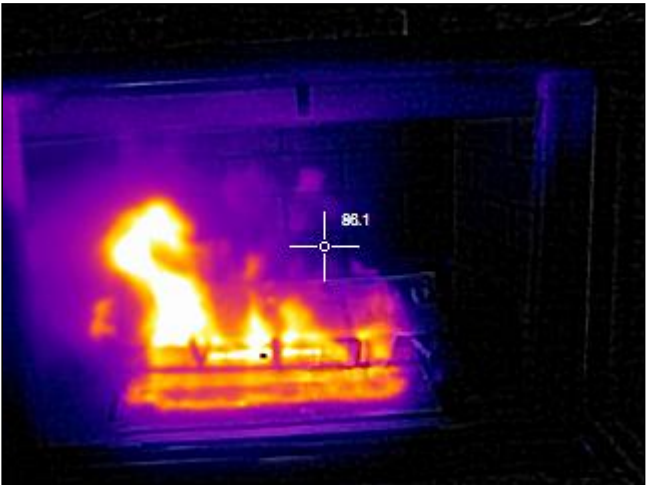
10.7 Item 1(Picture)

(1) The gas fireplace(s) was tested /operated for several minutes with no defects noted.

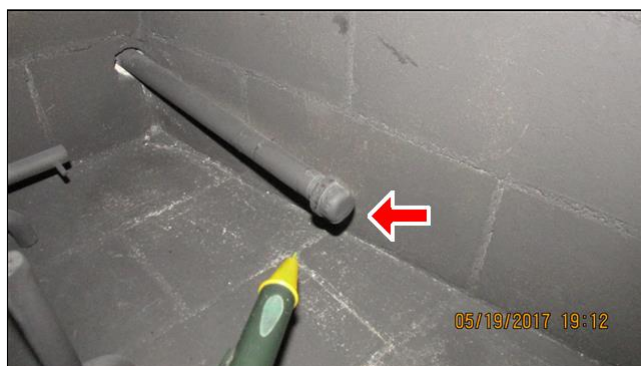
10.7 Item 3(Picture)

- ☒ (2) No gas service. Fireplace not tested. You should verify normal operation prior to closing date.

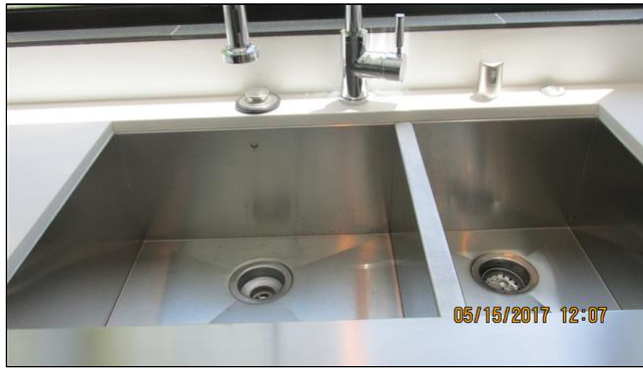
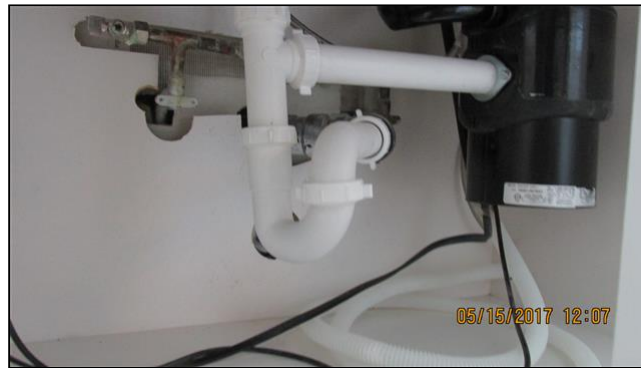
11.2 Item 1(Picture)

The kitchen sink(s) and visible plumbing exhibit typical wear and tear normal for this heavily used component. The flaws are cosmetic in nature. No remedial action is indicated.

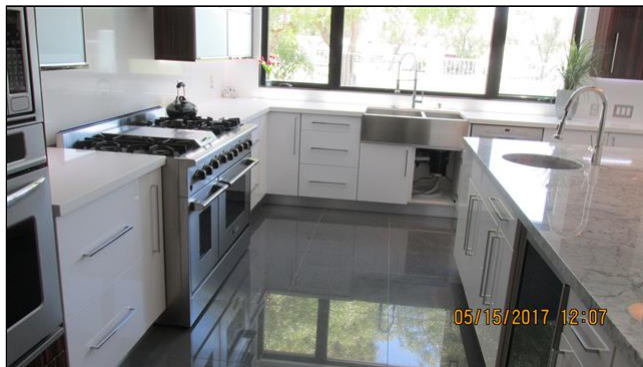
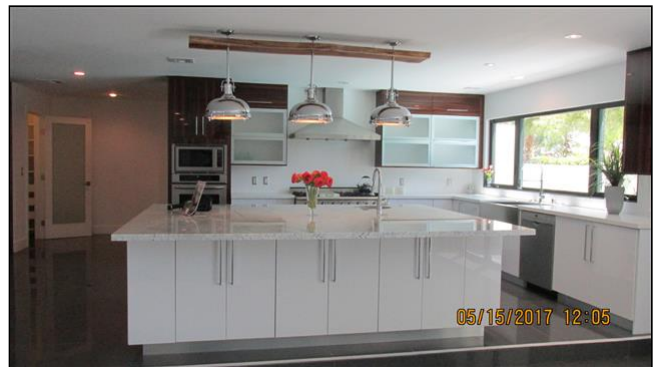
11.3 Item 1(Picture)

The countertop exhibits typical wear and tear normal for this heavily-used component. The flaws are cosmetic in nature. No remedial action is indicated.

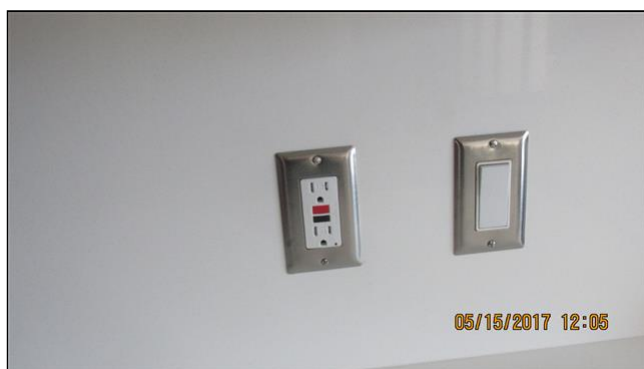
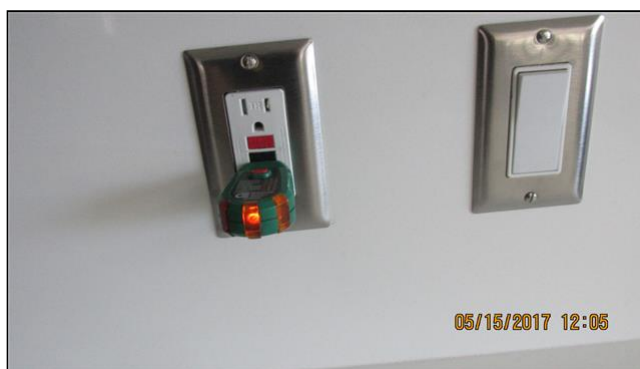
11.5 Item 1(Picture)

The kitchen GFCI protected outlets were tested and functioned as intended at time of inspection.

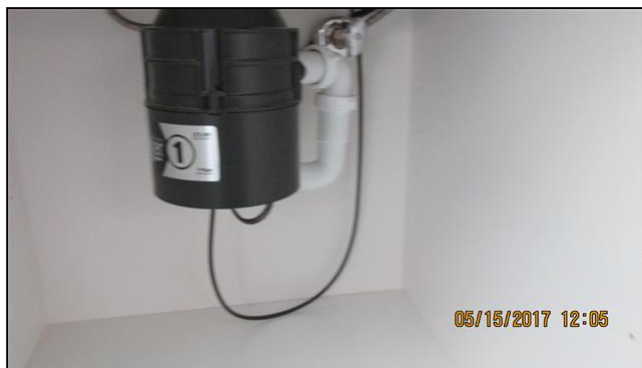
11.6 Item 1(Picture)

The disposal was operational at the time of inspection and no leaks in the housing was noted.

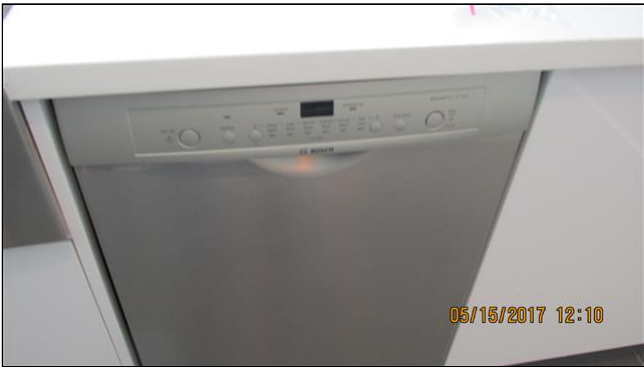
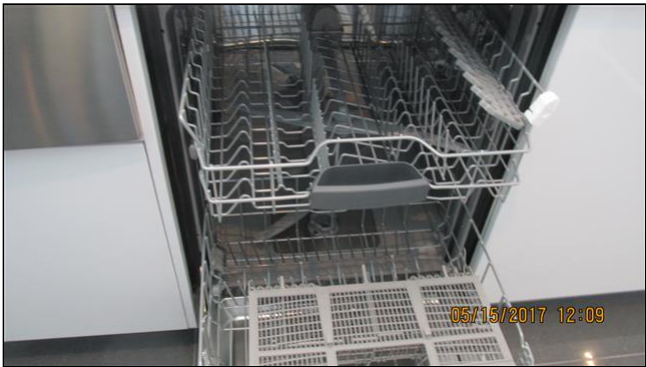
11.7 Item 1(Picture)

(1) During the inspection of the Dishwasher we only check the running cycles, Physical parts visible and the draining system. Checking of the Drying system is beyond the scope of this inspection.

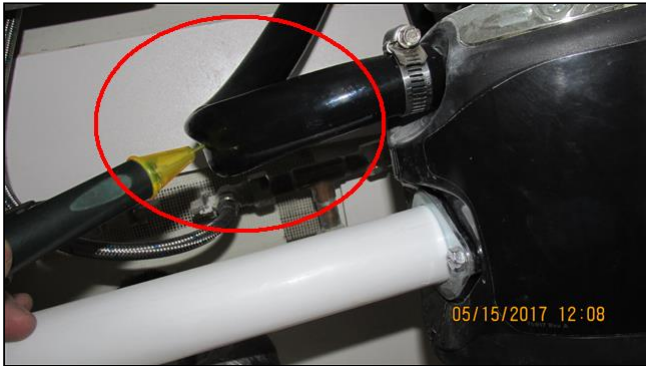
11.7 Item 3(Picture)

☒ (2) The air gap or its connection to the disposal is restricted or kinked. This causes water to flow out of the air-gap during the drain cycle of the dishwasher. The dishwasher drain system should be cleaned or modified to restore proper operation. A qualified technician could do the work.

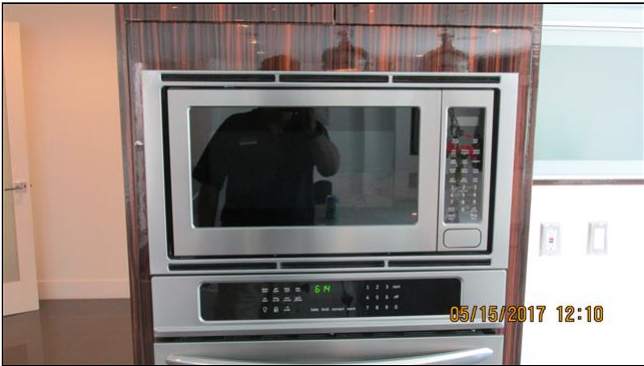
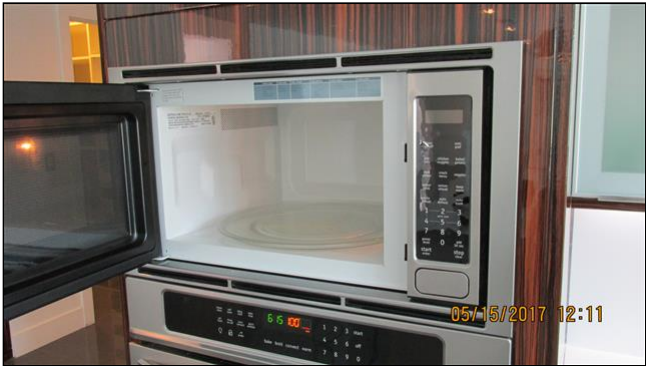
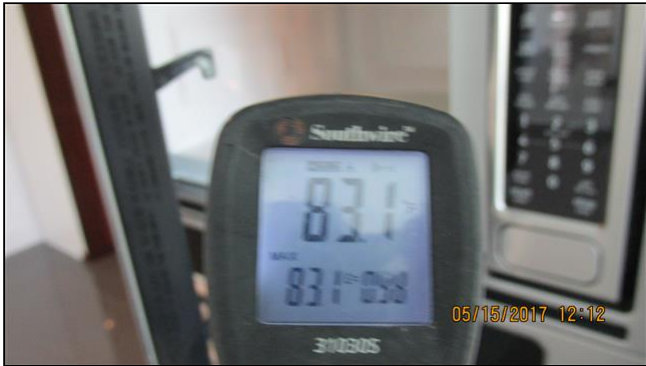
11.8 Item 1(Picture)

The microwave was functional when tested. the test consists of heating a cup of water on a 15 second cycle. we cannot confirm the operation of all features of the microwave.

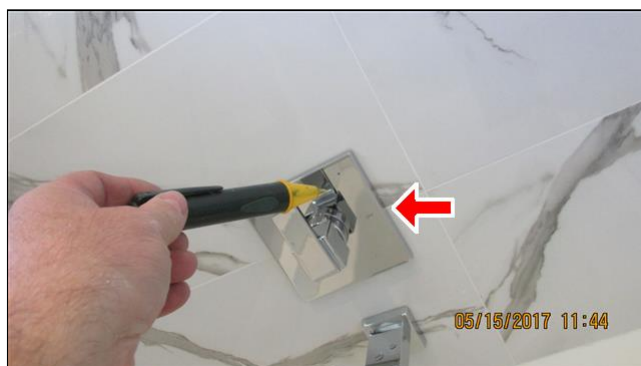
12.1 Item 1(Picture)

- ✘ (1) The hot / cold water lines at the Second Floor Guest Bathroom sink are reversed. Consult a qualified person for repairs.

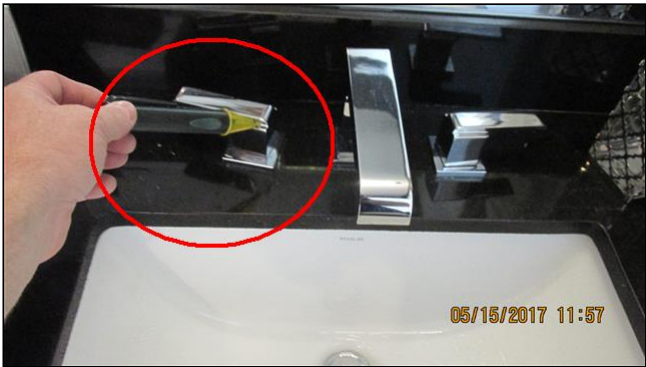
12.1 Item 4(Picture)

- ❌ (4) The Kitchen sink, Island Sink , guest bathroom and laundry room faucet is supplying only Cold water and needs repair. I suggest a Professional Plumber be consulted.

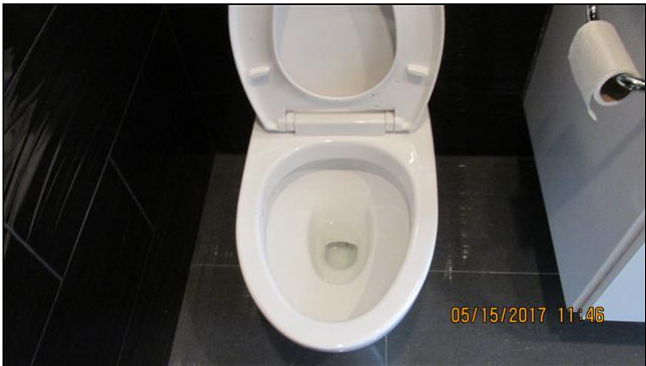
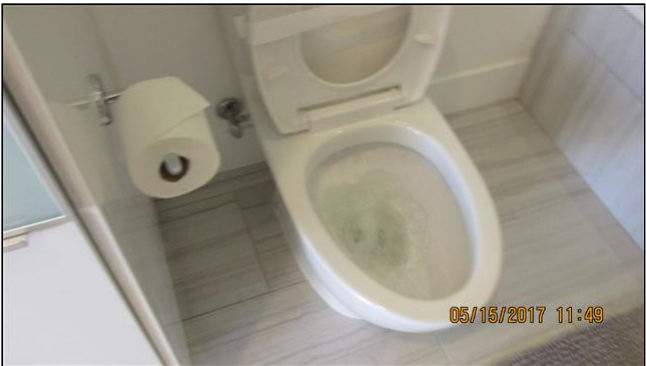
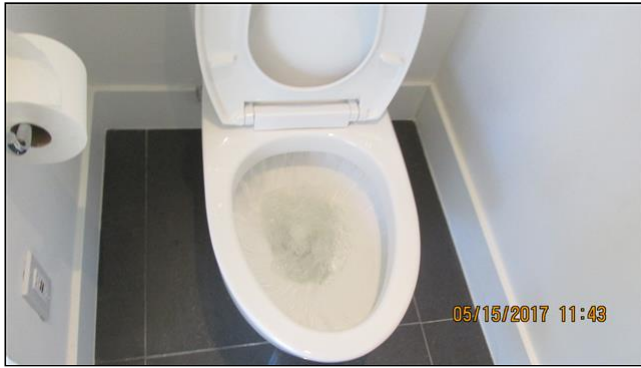
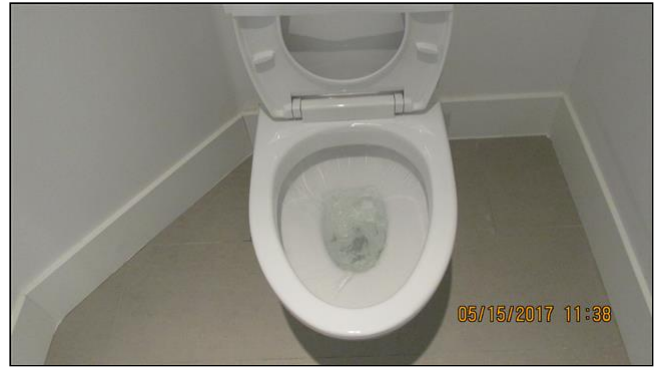
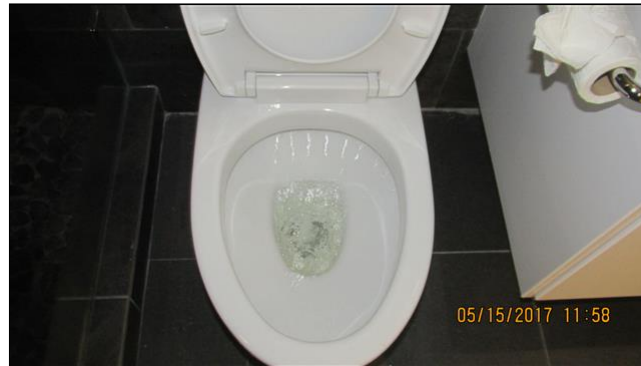
Comments: Inspected
The toilets flushed and were not loose on the day of the inspection.

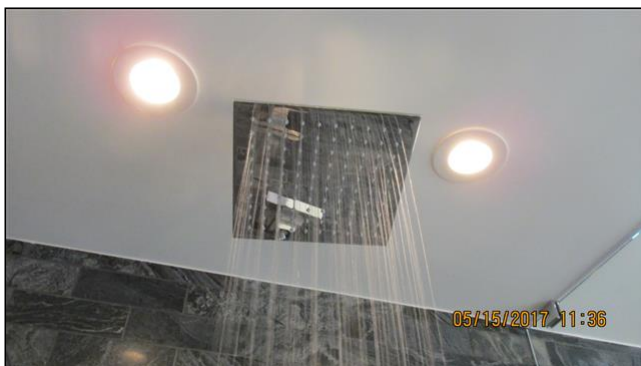
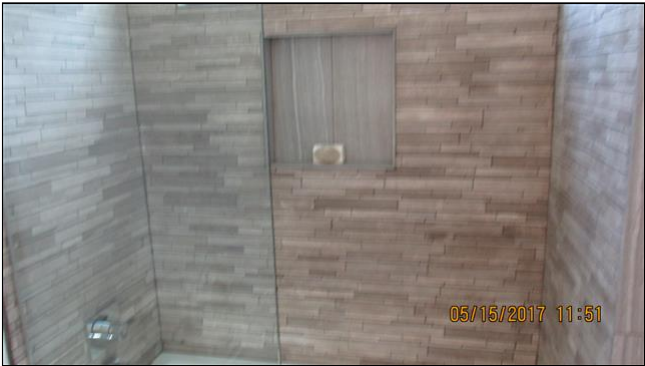
The shower-tub enclosure was in acceptable condition with no deficiencies on the day of the inspection.
