NEVADA PROPERTY CONCEPTS

Inspection Report

Property Address:
2870 Augusta Dr.
Las Vegas NV 89109

Date: 5/15/2017	Time: 09:00 AM	Report ID: 20170515-09.00SP
Property: 2870 Augusta Dr. Las Vegas NV 89109	Customer: Mr. Phil Edgar	Real Estate Professional: Jamie Tsai O' Harmony Realty LLC.

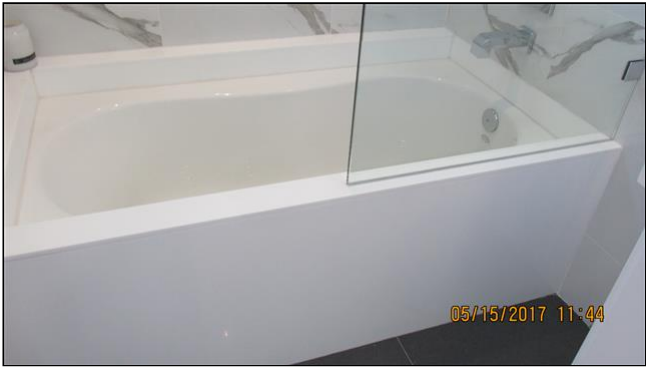
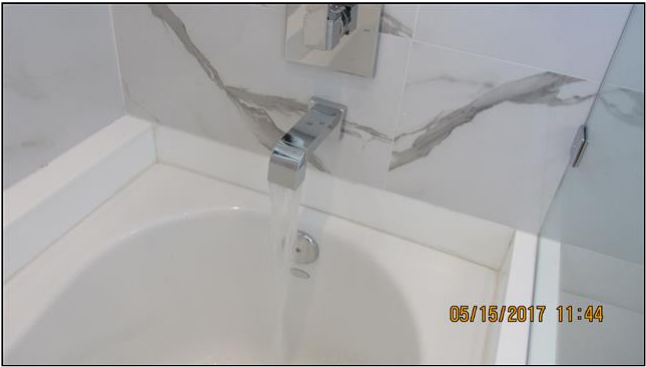
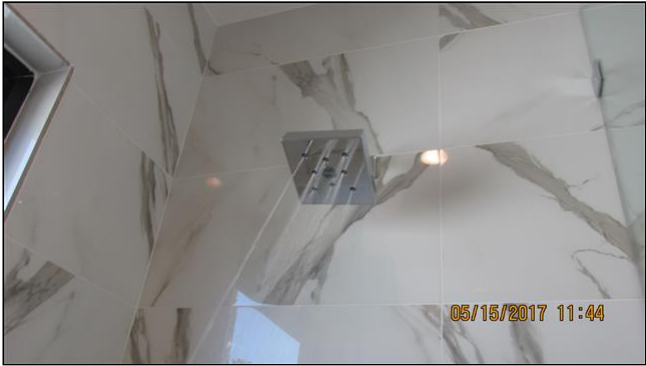
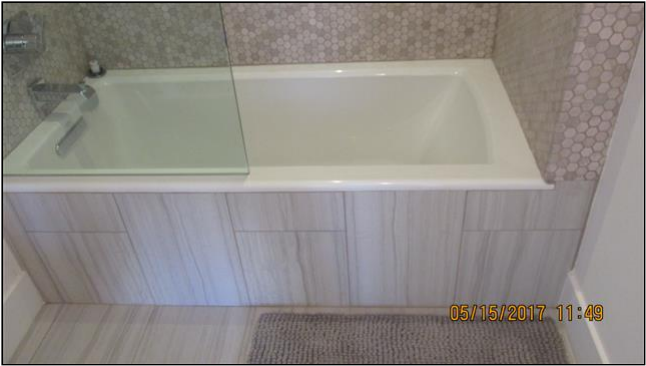
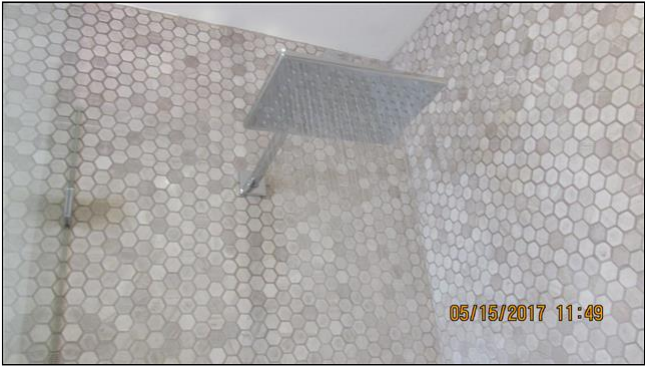
The bathtub was filled and drained at the date of inspection. No significant defects were observed. The tub drained in accordance with standards.

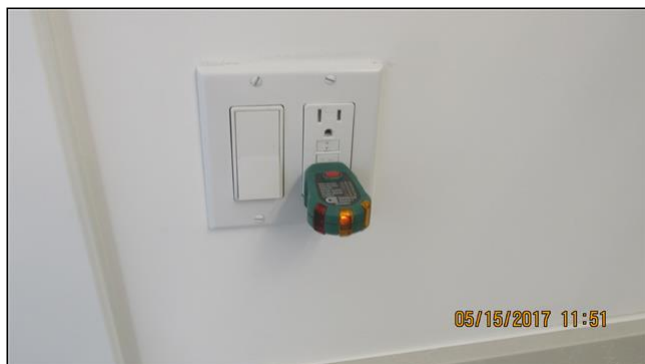
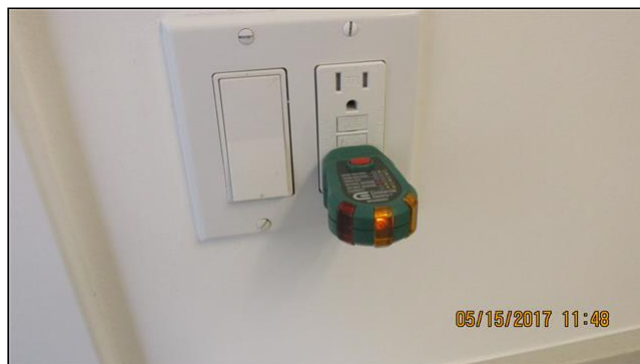
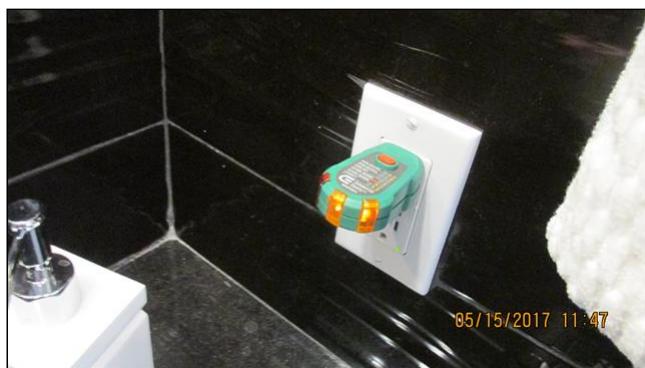
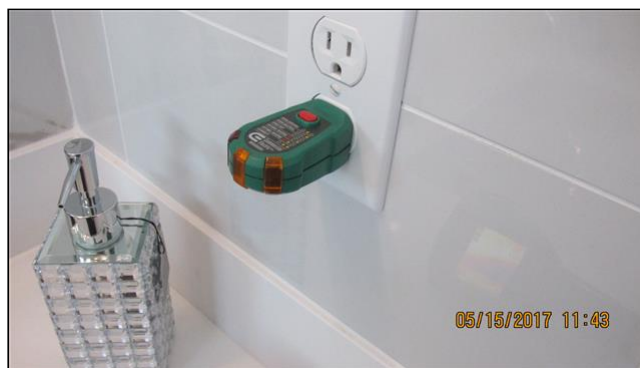
The bathroom Ground Fault Circuit Interrupter (GFCI) outlets were tested and functioned as intended at time of inspection.

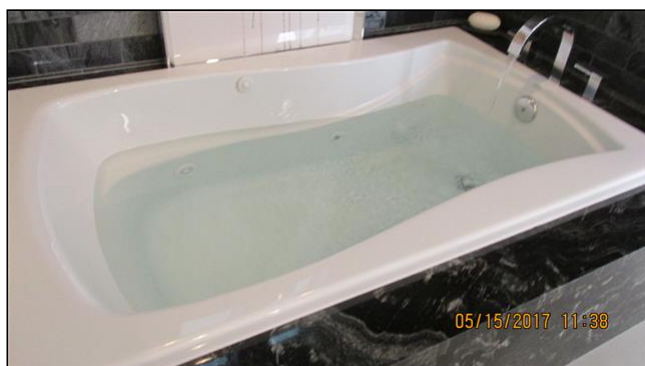
12.9 Item 1(Picture)

The whirlpool tub is not functional. A qualified technician should evaluate the system and make repairs or modifications as necessary.

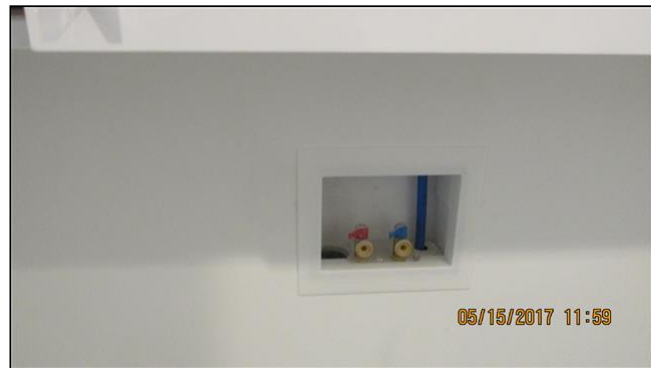
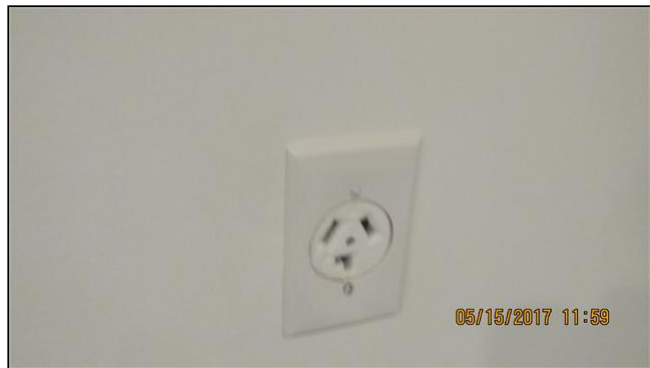
The plumbing connections for the washing machine were not leaking on the day of the inspection.

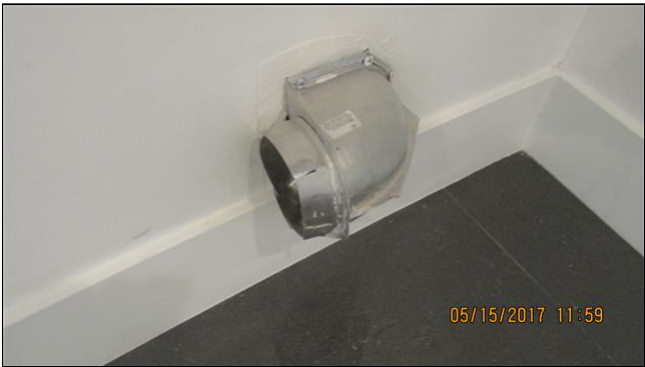
13.6 Item 1(Picture)

The dryer vent line vents to the building exterior.

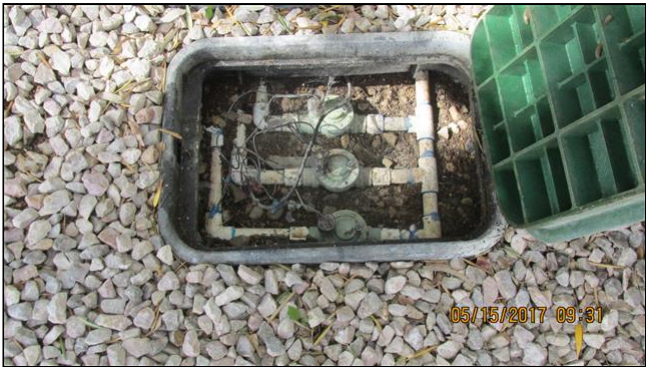
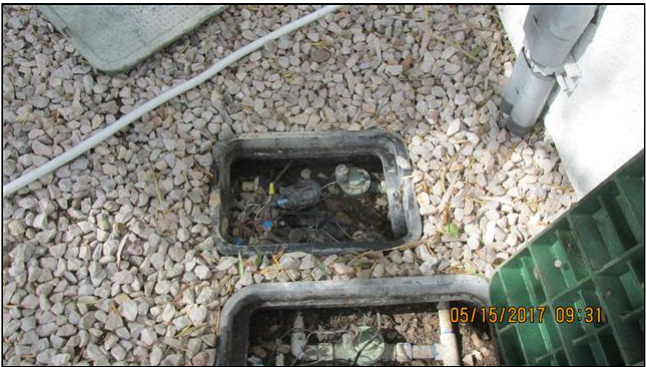
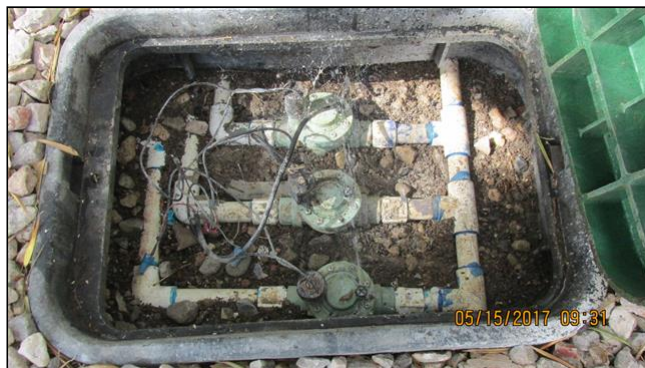
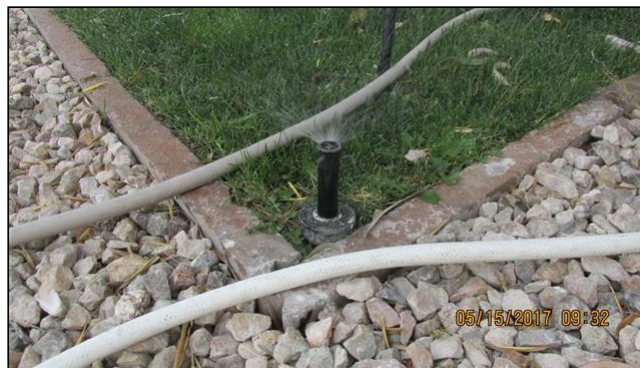
The drip irrigation system was tested using water valves and not the lawn clock so as not to effect the watering programming and performed with out defect.

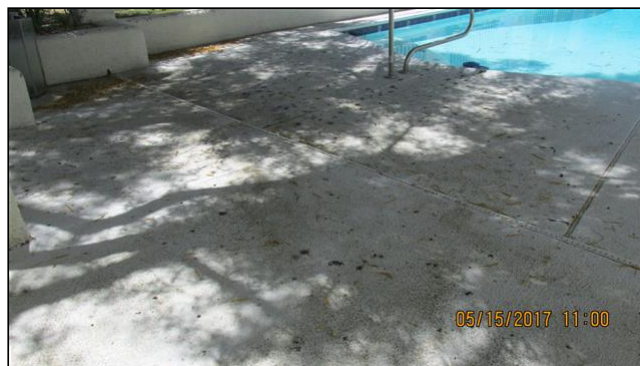
15.2 Item 2(Picture)

The pool and or spa decking shows typical cracks and wear. Any missing, chipped or cracks are cosmetic and can be repaired.

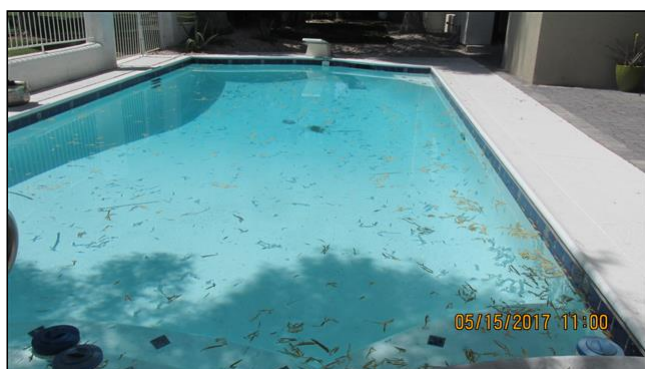
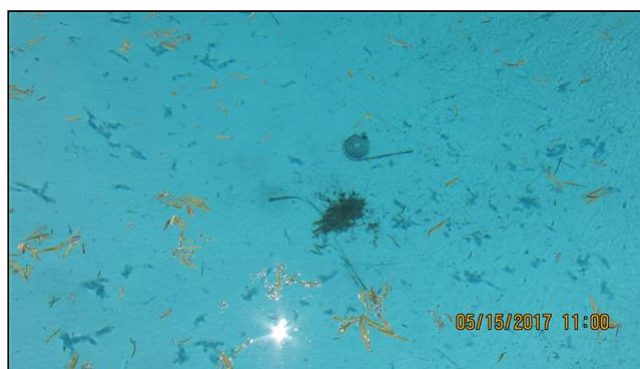
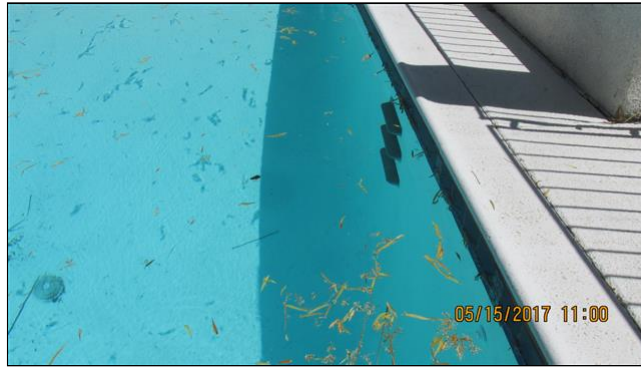
The pool and or spa vessel surface material was in acceptable condition and showed no signs of any major flaws on the day of the inspection. Typical cosmetic wear was observed.

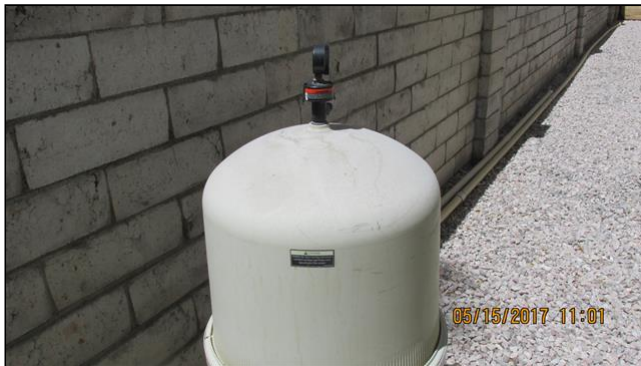
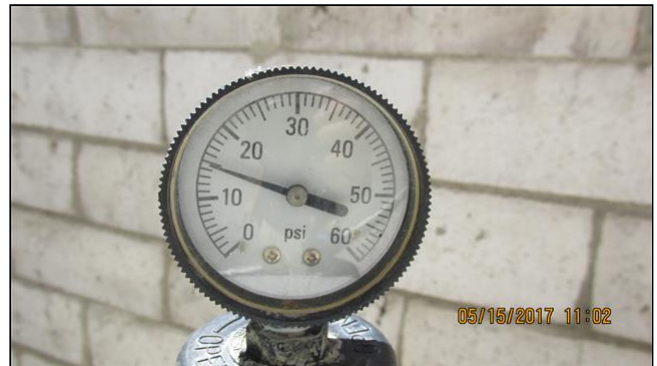
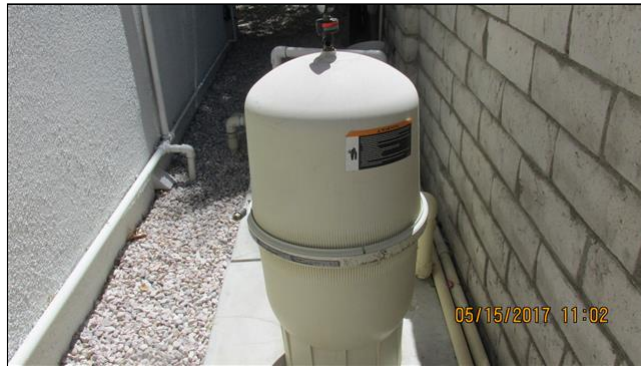
The filter and return lines to the pool and or spa were functioning normally at time of inspection.

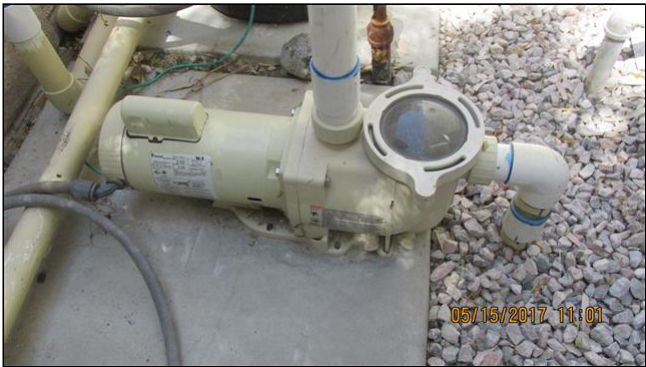
15.5 Item 1(Picture)

☒ There are water leaks at the pump. A qualified technician should make repairs or modifications as necessary.

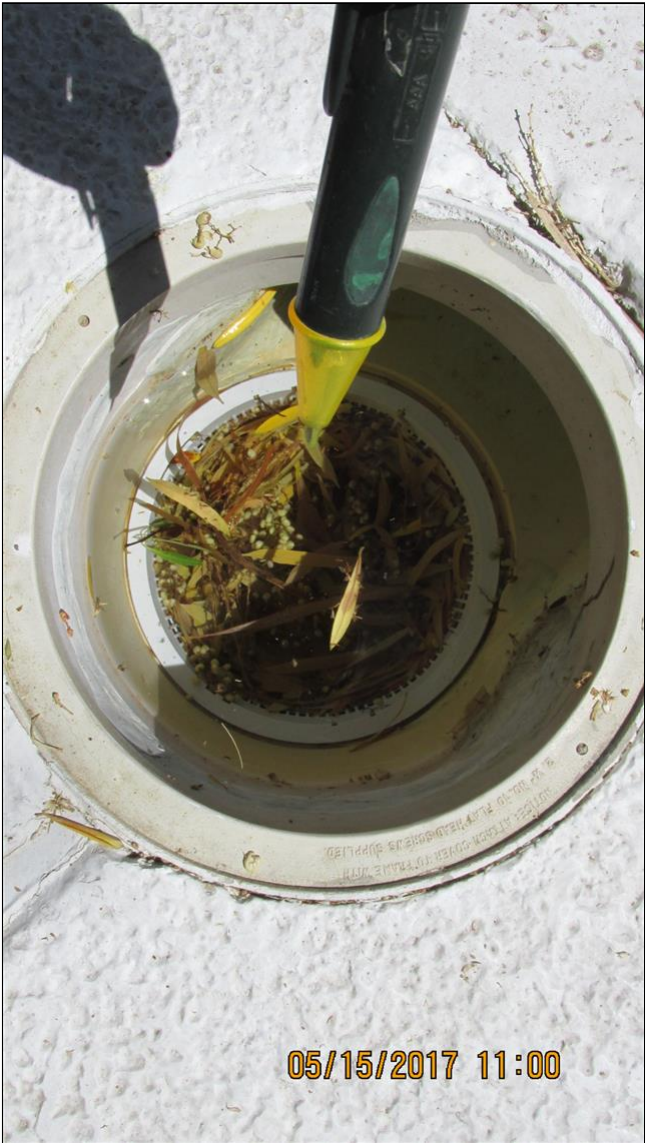
15.6 Item 1(Picture)

The skimmer(s) and drain(s) were intact and functional at time of inspection. Skimmers must be empty of debris at all times.

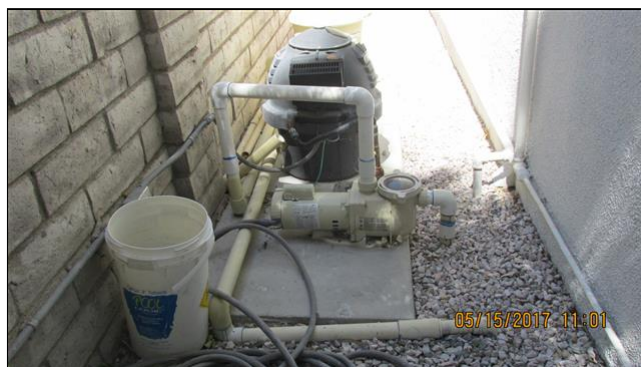
15.7 Item 1(Picture)

The pool and or spa plumbing was intact and functional at time of inspection. However, it should be noted that leaks can occur at any time and you should observe the plumbing during operation periodically.

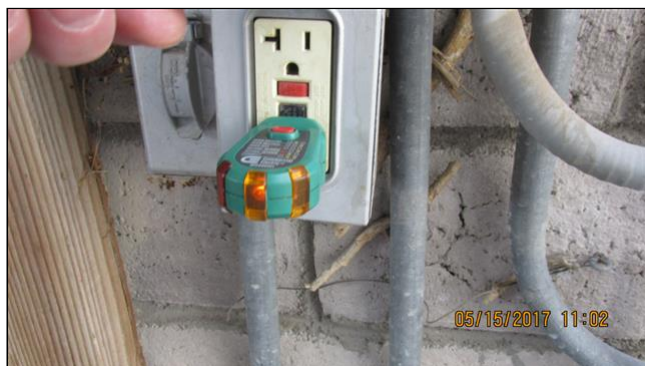
15.9 Item 1(Picture)

- ❌ (1) The GFCI circuit installed to protect the pool light is not functional (did not trip when tested) and needs replacement.

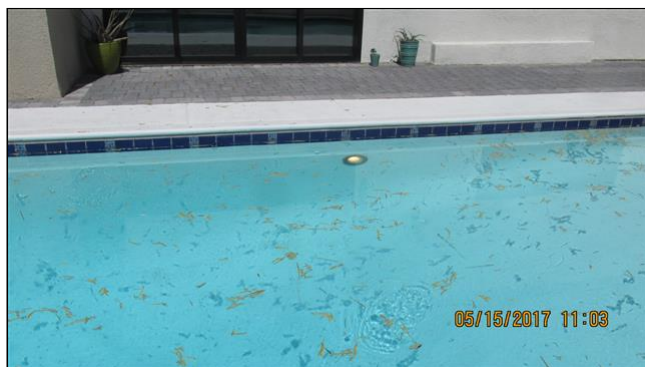
15.9 Item 3(Picture)

- (2) The pool light, GFCI protection for pool light and all wiring were intact and functional at time of inspection.

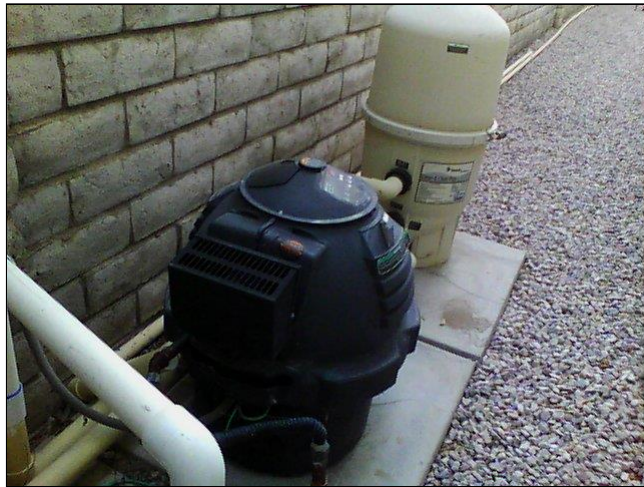
15.10 Item 1(Picture)

The pool and or spa heater was operated and found to be in satisfactory condition at time of inspection. However, our inspection does include determining efficiency of the heating system.
