**NEVADA PROPERTY CONCEPTS**

# Inspection Report

**Property Address:**  
2870 Augusta Dr.  
Las Vegas NV 89109

<b>Date:</b> 5/15/2017	<b>Time:</b> 09:00 AM	<b>Report ID:</b> 20170515-09.00SP
<b>Property:</b> 2870 Augusta Dr. Las Vegas NV 89109	<b>Customer:</b> Mr. Phil Edgar	<b>Real Estate Professional:</b> Jamie Tsai O' Harmony Realty LLC.

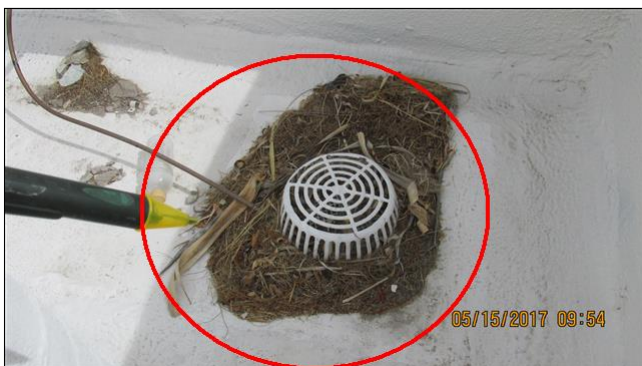
4.5 Item 1(Picture)

A section of the internal roof drains are clogged with debris, and are not draining as intended.

- SUGGESTION: All debris should be cleared from the roof drains, and the drains should be tested to ensure proper function.
